GATEWAY PROGRAM DEVELOPMENT CORPORATION RELEASES INDEPENDENT ANALYSIS OF NORTH RIVER TUNNEL REHABILITATION

Conceptual study by London Bridge Associates believes that full rehabilitation of tunnel “in-service” with the same scope and useful life, in conjunction with construction of new tunnel may be feasible and improved customer experience may be possible sooner if a number of pre-construction activities are undertaken immediately and expedited to completion. GDC and Partners to consider recommendations.

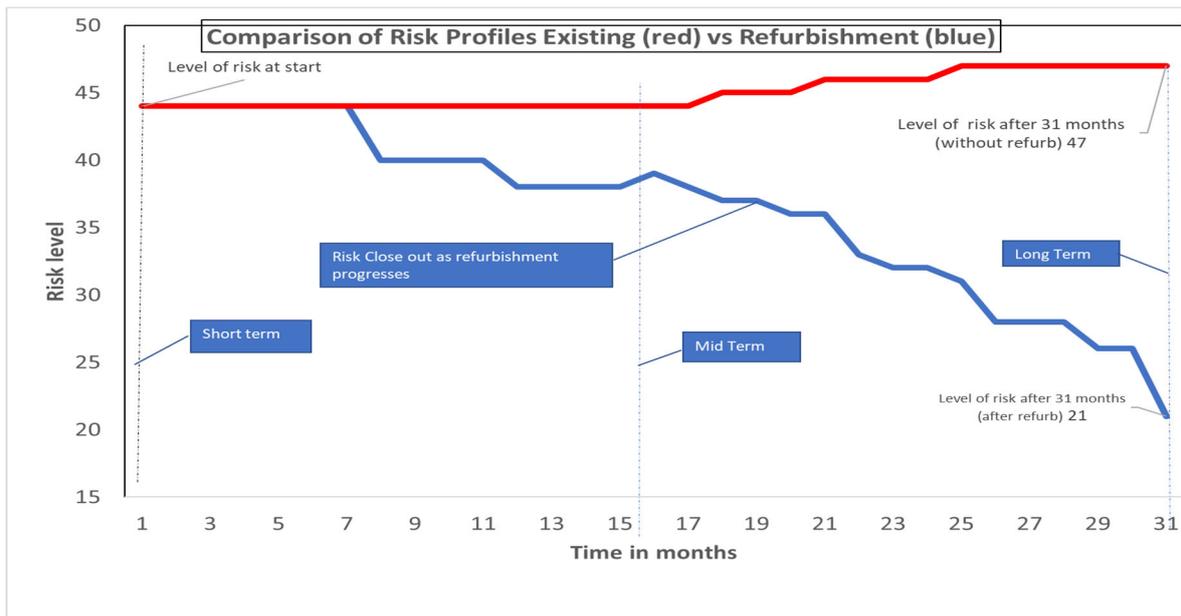
LBA agrees that the current proposed one tube out-of-service NRT Refurbishment solution offers a reliable risk-averse approach. However, it disregards the highly probable operational and reliability risks to Amtrak and NJ TRANSIT and their customers in not commencing any essential NRT Refurbishment until at least 2028 with probable completion not before 2032, some 12 years hence. The chart in Figure 2-1 shows a conceptual comparison of the risk profiles of the “Existing (and continuing) Risk” against the “Refurbishment Risk.” The Refurbishment Risk profile decreases as the new or replacement infrastructure and services are installed, whereas the Existing Risk remains and over time increases.

Figure 2-1: Comparison of Risk Profiles Existing vs Refurbishment

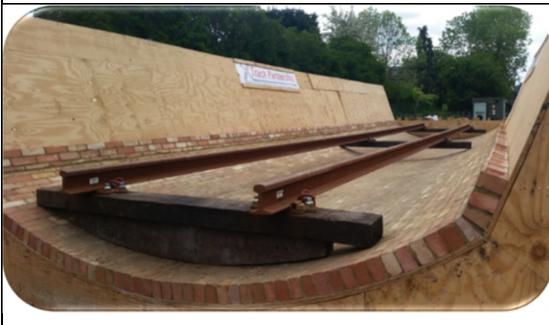
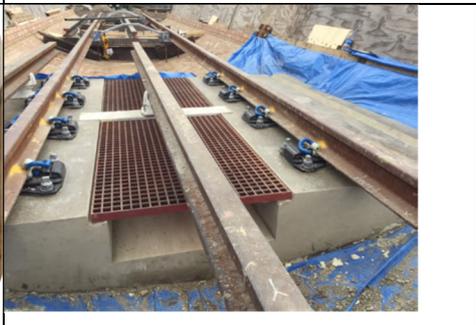
The photographs below are examples of the mock-up of the Baker Street to Finchley Road London Underground (UK) Renewal:

<p><i>Figure 2-2: A carefully constructed replica of a section of the tunnel invert</i></p>	<p>Figure 2-3: The “tunnel mock-up” for inspection and acceptance by all</p>	<p><i>Figure 2-4: Mock-up concreting trial</i></p>

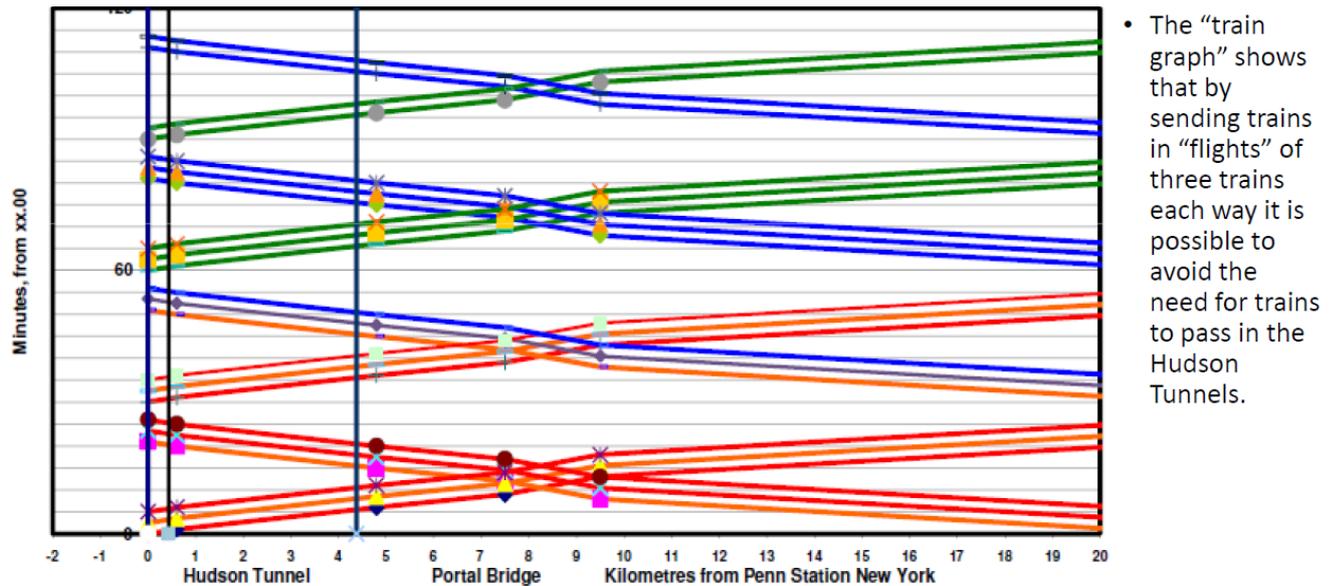
Figure 5-3: “Train Graph” developed by LBA and derived from the draft timetable for a maximised frequency of overnight or weekend passenger train services using one of the NRT tubes as a single track railway

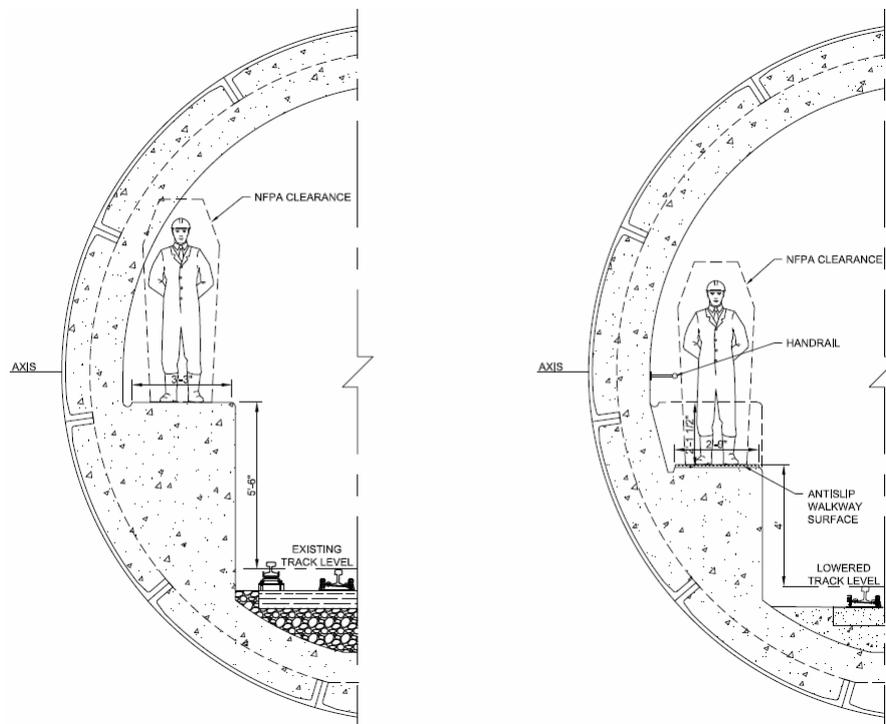
In addition, emergency egress access must be provided for workers to the escape walkway under FRA requirements.

Figure 8-1: Increased walkway headroom and reduced stepping distance from emergency train egress following bench lowering

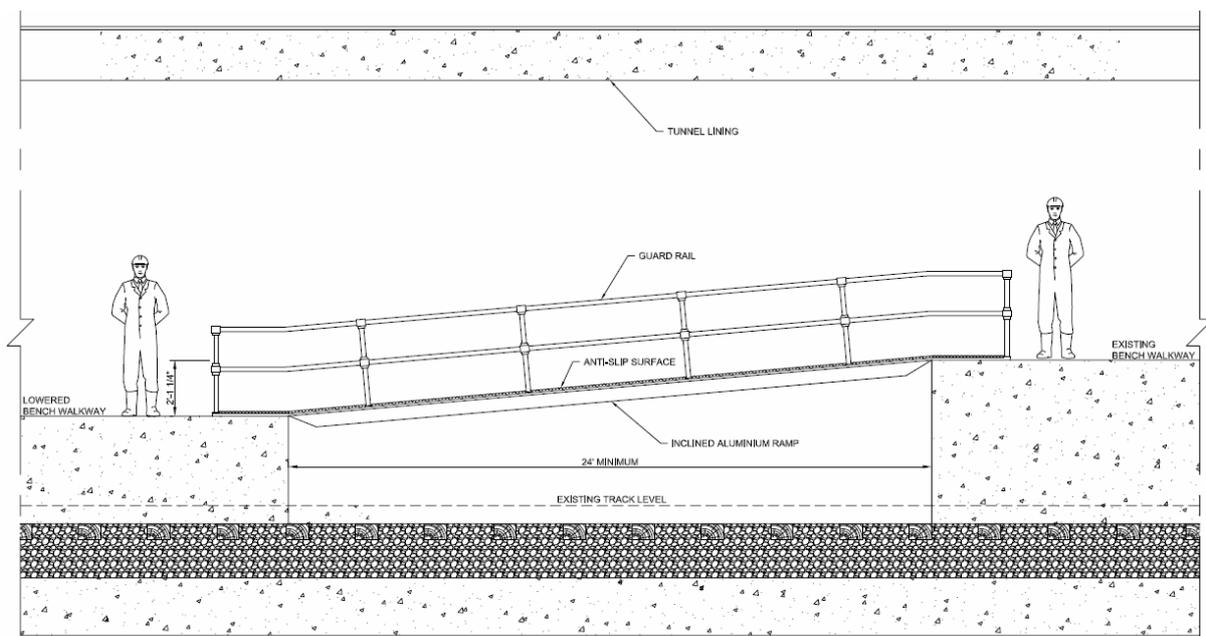
The span of the gap and slope of the ramp will depend on the construction design and programming and may also vary as work progresses but is likely to be at least 24 feet in length manufactured from aluminium to reduce weight. Consequently, it may be necessary to have a selection of ramp lengths and gradients available or to devise an adjustable, possibly telescoping, ramp. The ramp would also require a guard rail on the track side. Since the ramp would be relatively short in length, a track side guard rail would be preferable and should not present a significant risk. However, the safety implications will need to be carefully considered in the design of the ramp. In addition, the ramp will need to be firmly fixed in place to prevent any displacement owing to the draught caused by passing trains.

Figure 8-2: Demountable steel ramp spanning the gap between existing and the new walkway bench.

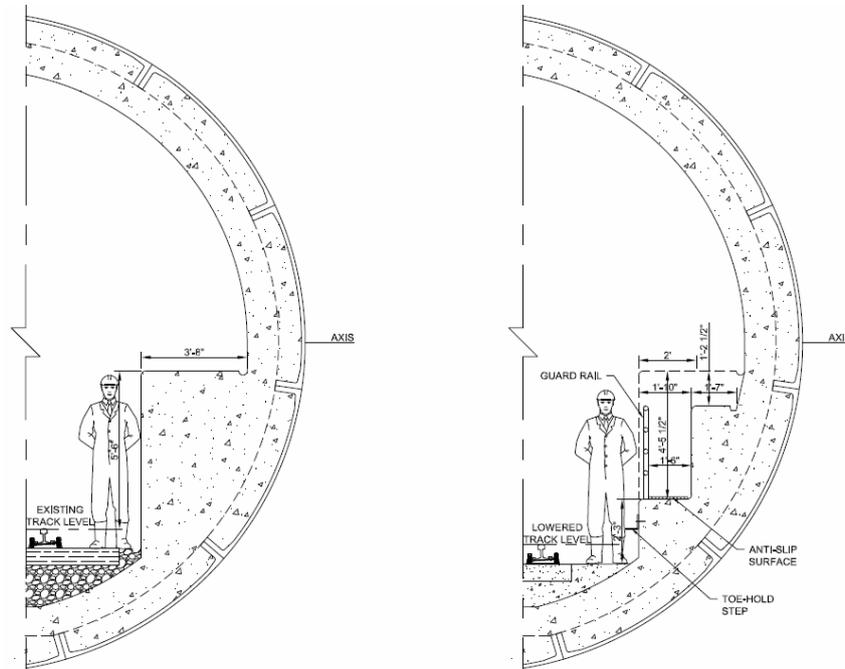
There is also a need to replace the existing bench wall on the opposite side of each tube from the emergency walkway discussed above and provide a new maintenance walkway for railway workers. The main consideration in the design is a safe maintenance platform to replace the existing refuges set in the side of the existing concrete. The platform will need to be at a suitable stepping distance from the lowered track bed (see *Figure 8-3*).

Figure 8-3: Provision of a safe refuge working platform following bench lowering

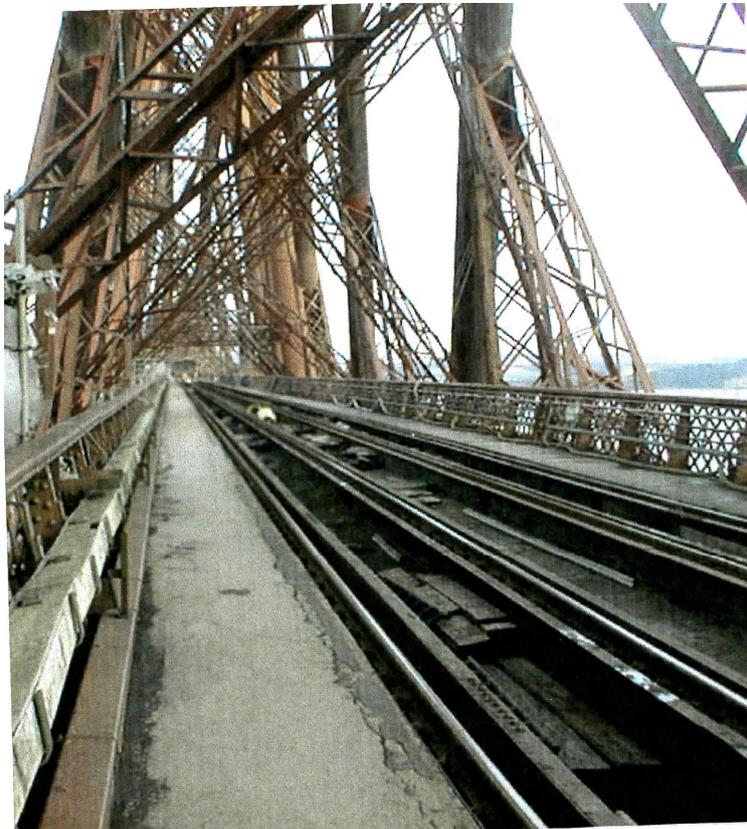
In the UK and elsewhere in Europe it is common practice to install "anti-derailment rails" or "guard rails" along the complete length of track crossing vulnerable bridges and viaducts. The guard rails are arranged to provide, in effect, a flangeway inside each of the running rails with a clear width of 3.75" (95mm). This is much larger than the 1.75" (44mm) flangeway provided at switches.

Figure 9-1: Guard rail

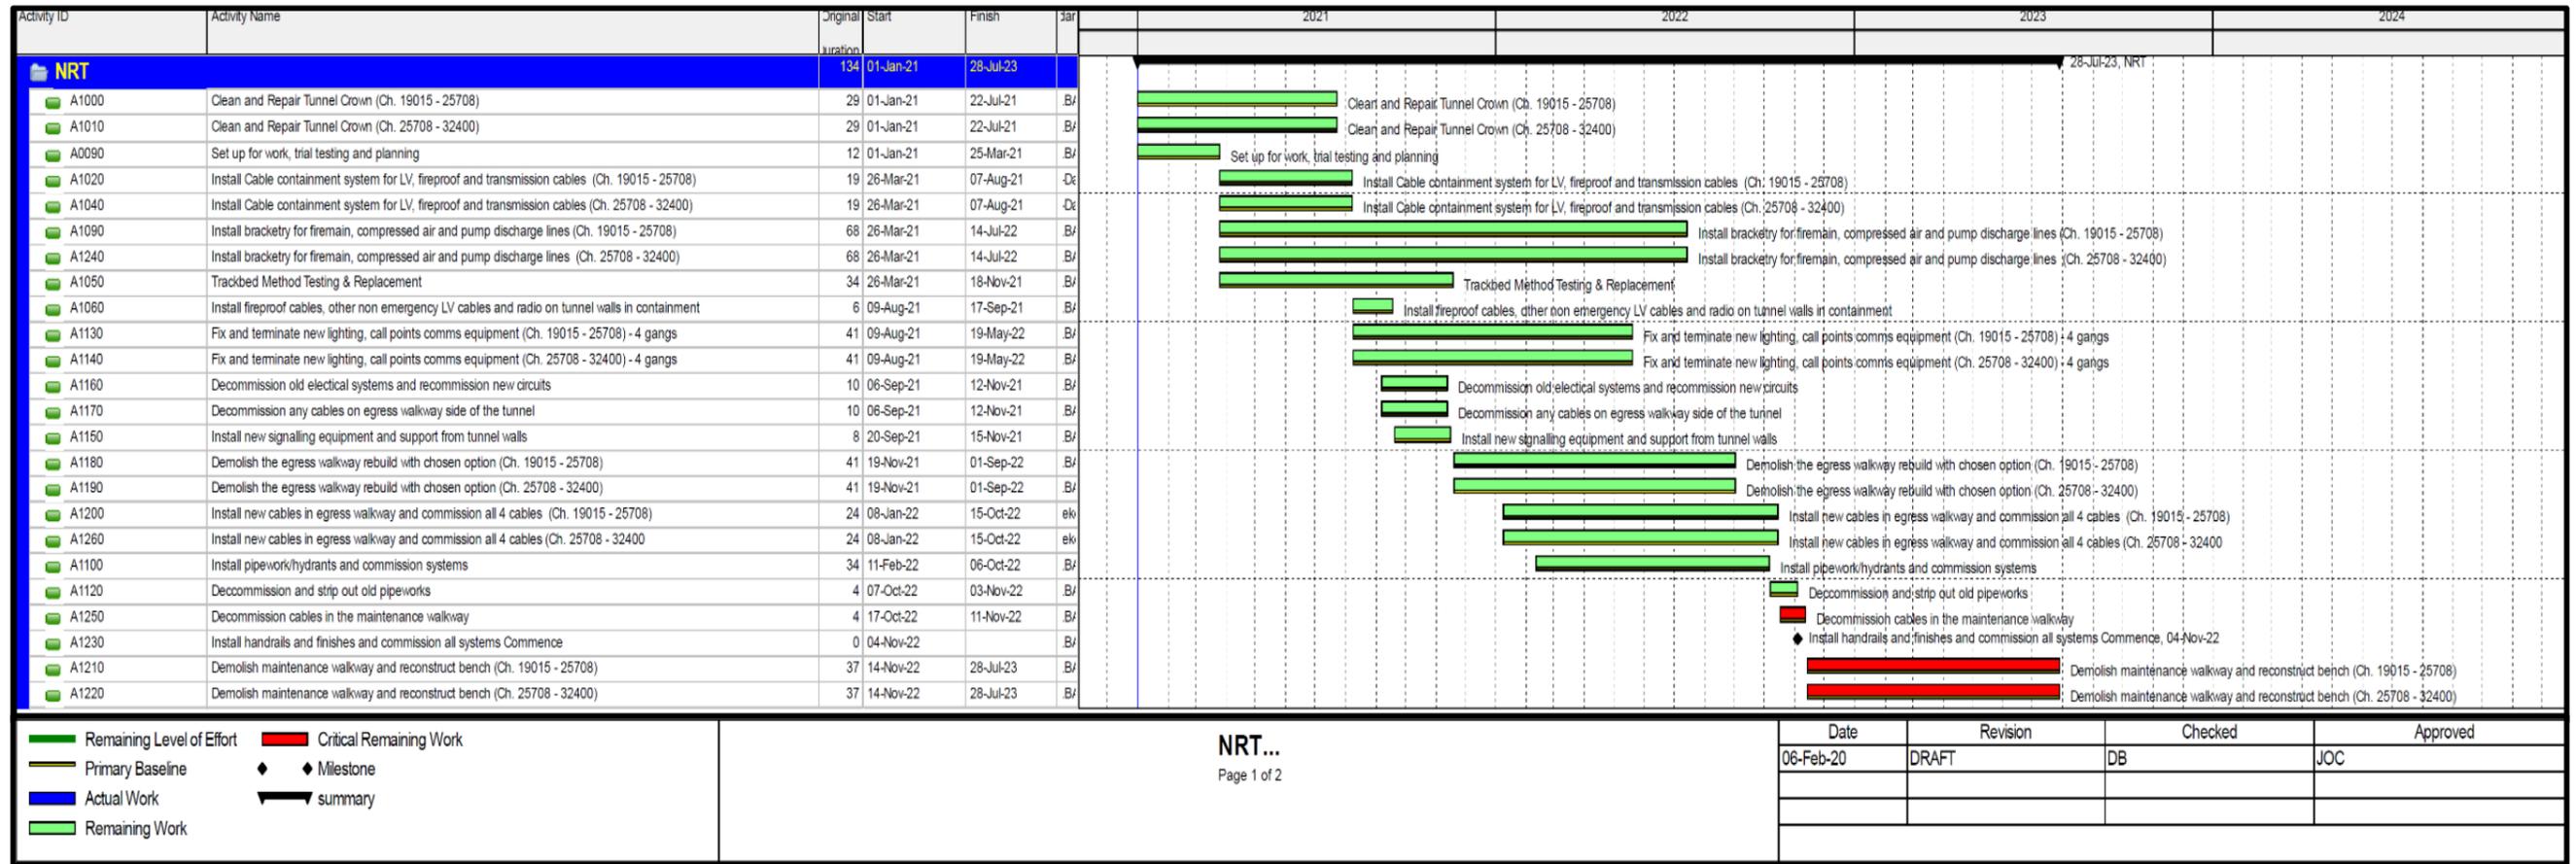
Figure 10-1: Gantt chart for in-service refurbishment works

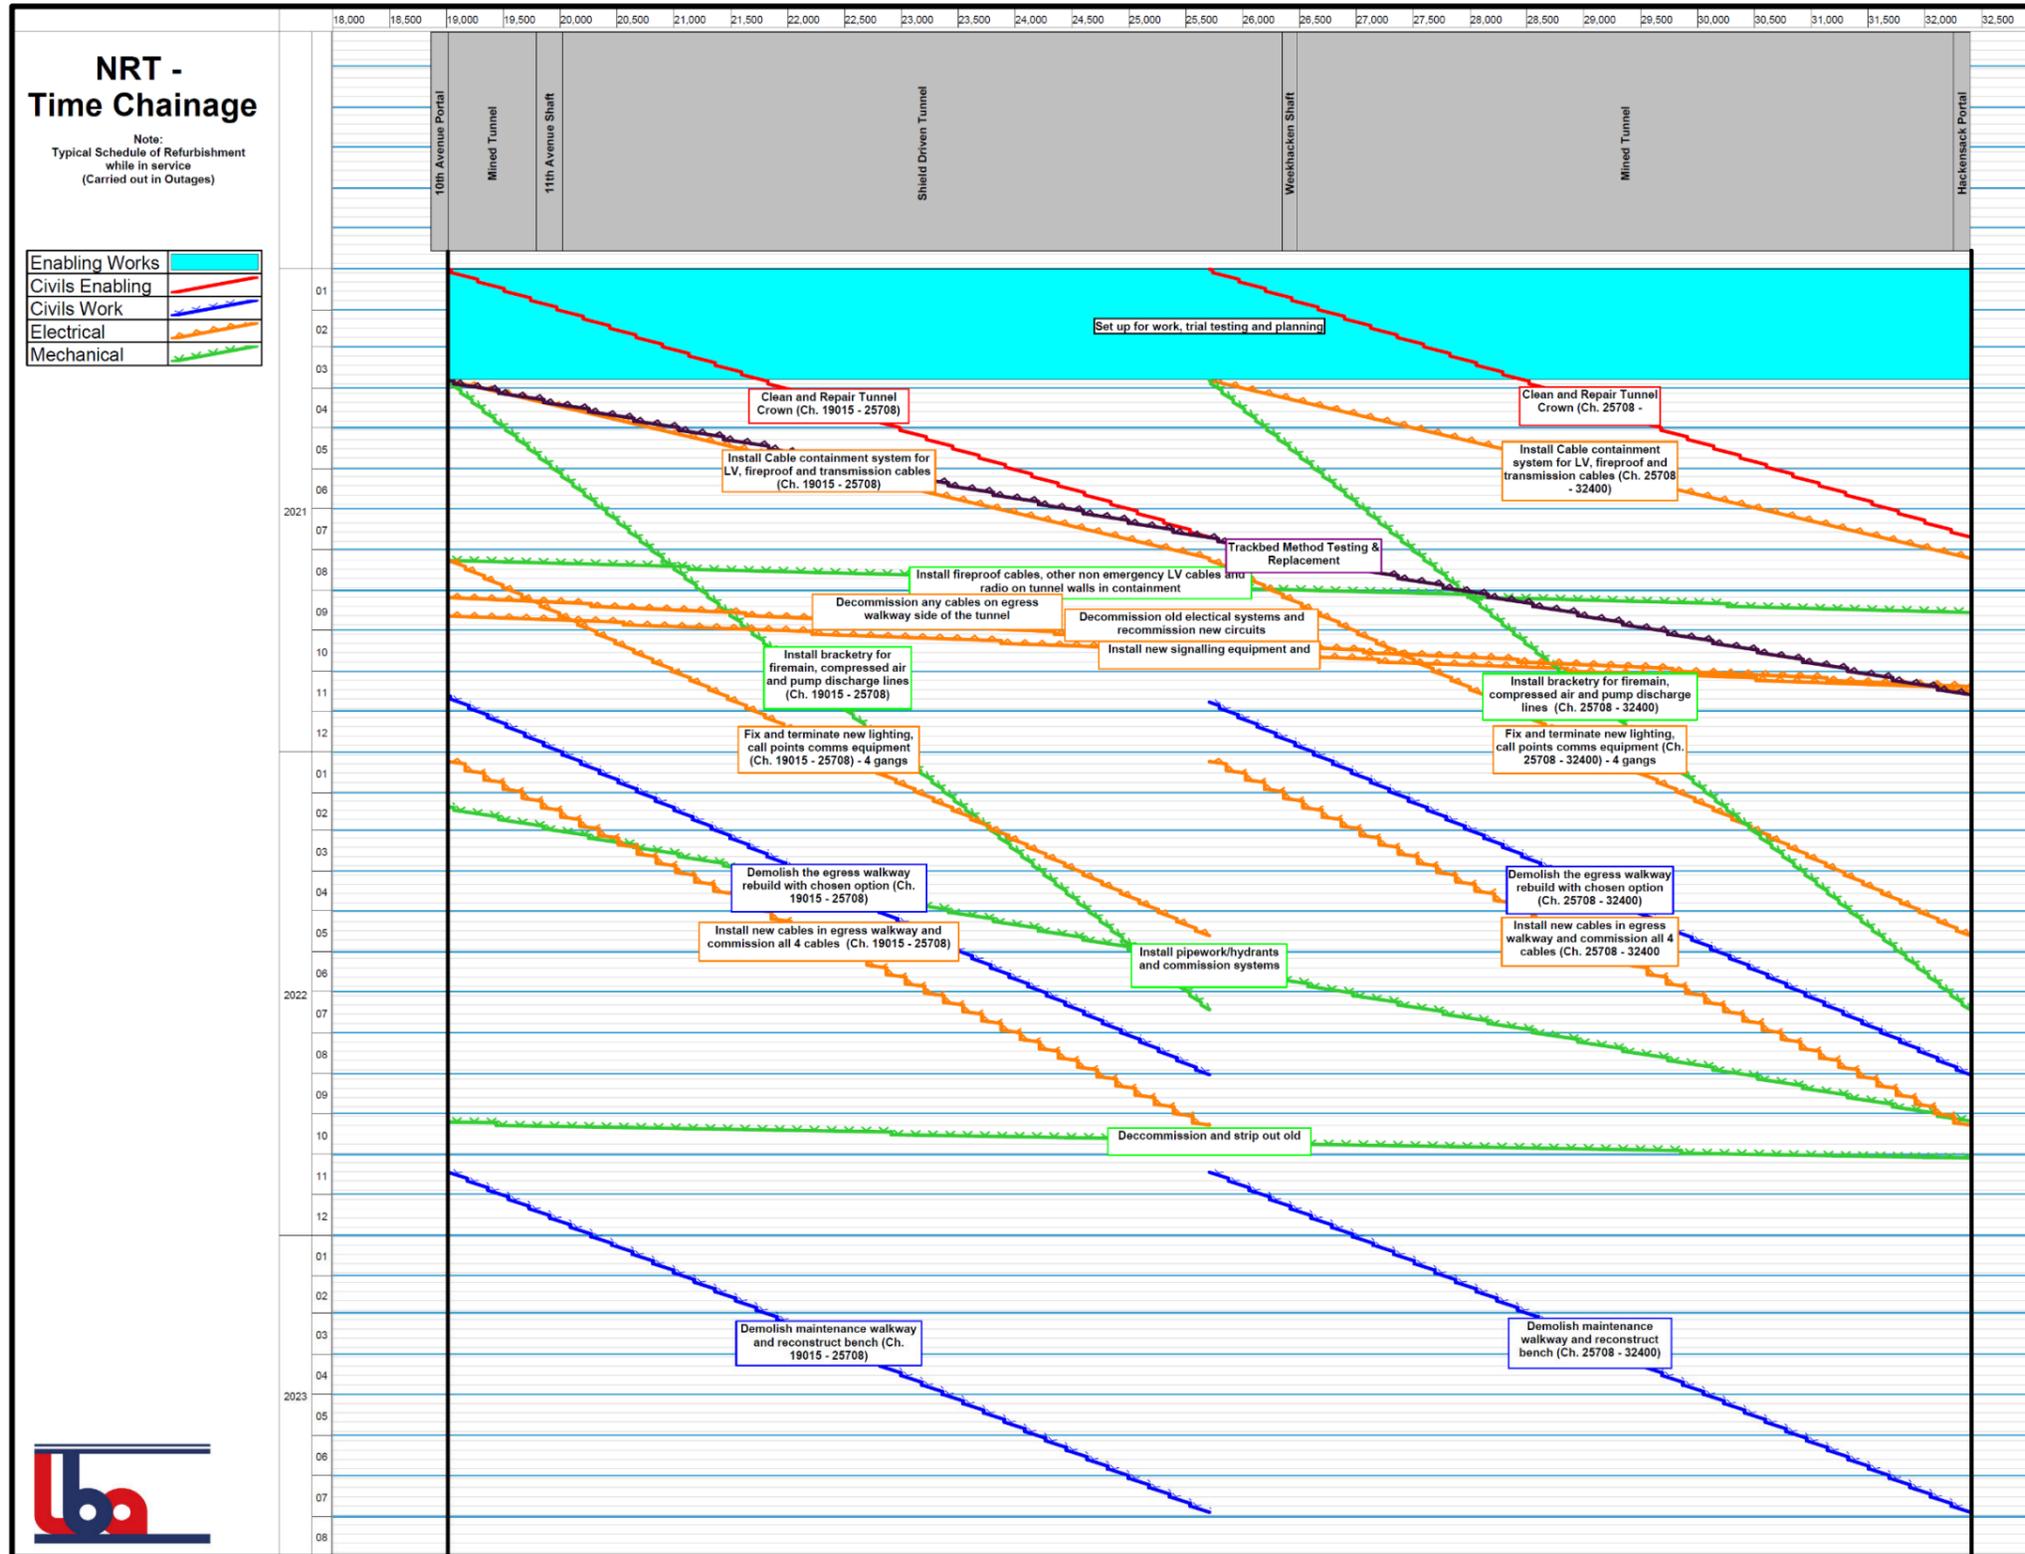
Figure 10-2: Time-chainage diagram for in-service refurbishment works

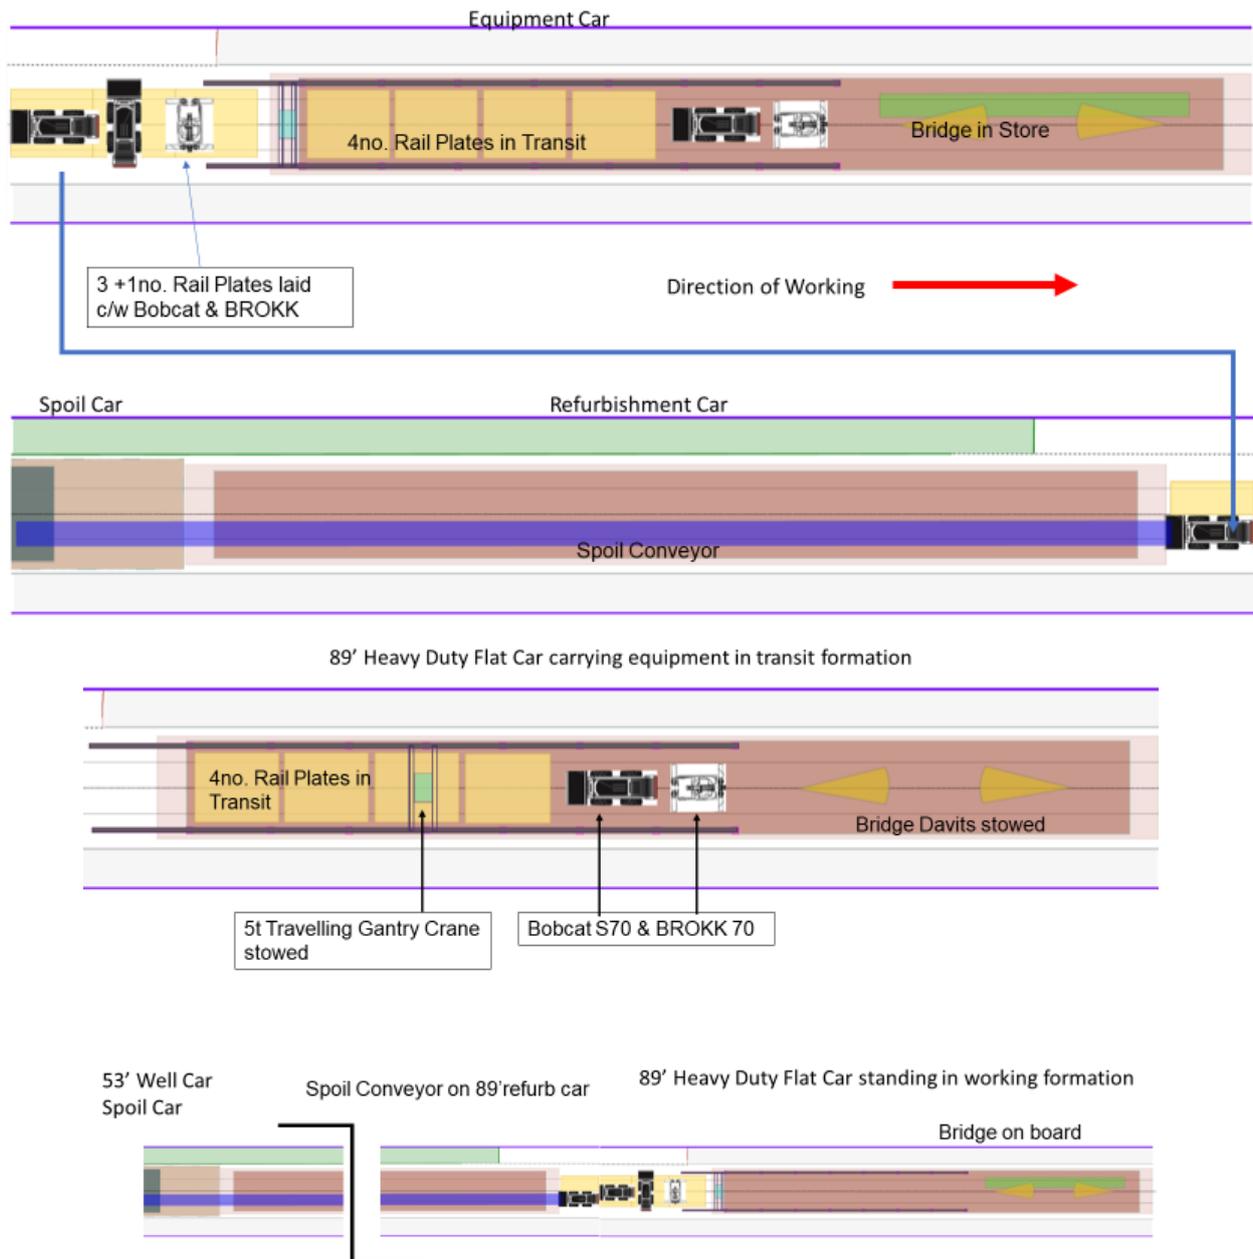
Further details of our planning and our suitable plant for bench demolition and reinstatement are provided in APPENDIX 4 - Bench Demolition and Reinstatement Methodology.

Figure 10.1 Schematic set up of possible works train for bench wall demolition and reinstatement

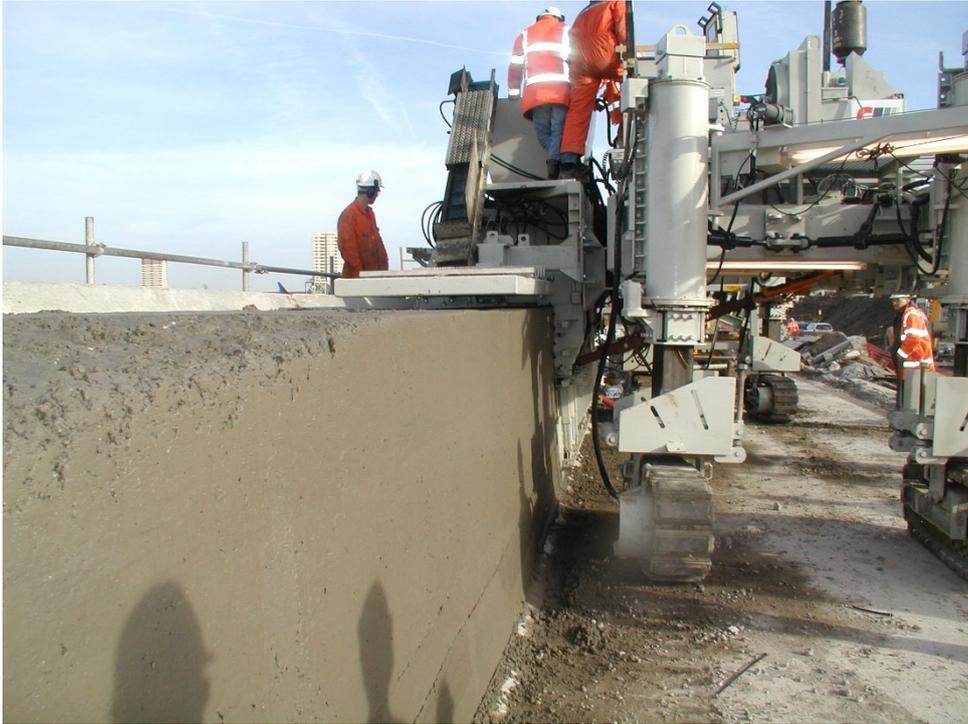
- v. A section of an NRT tube could be identified to carry out a "Pilot" study to test the planned method and equipment. This type of study would be subjected to the same rigours of planning and risk management as the main works and used to inform the future construction methodology.

Figure 10-3: Mock-up built to trial method and develop concrete mix and concrete finish for Slipform paved Haunches for HS1 London Tunnels Alliance

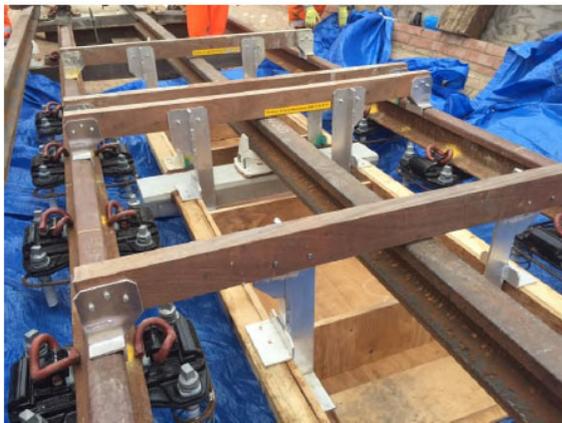
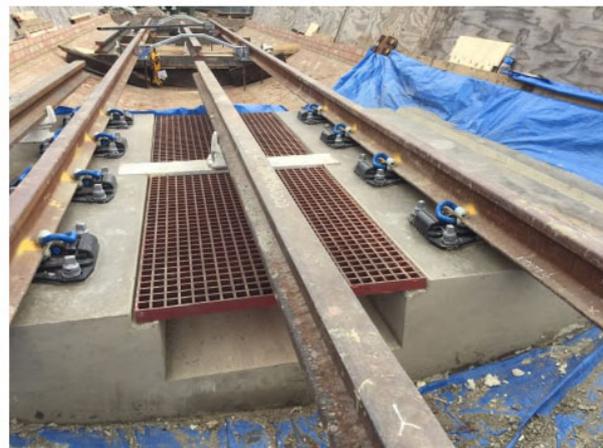
Figure 10-4: LUL Baker Street to Finchley Road Mock-Up Trials

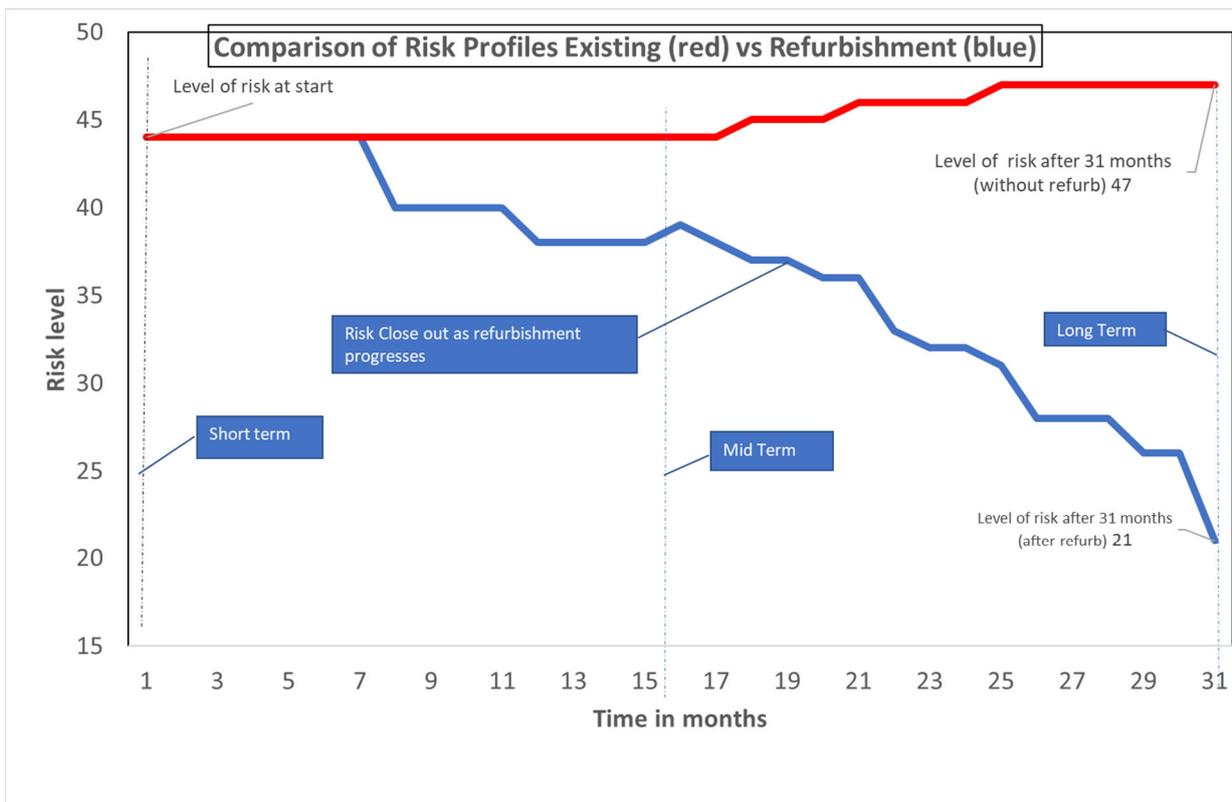
As can be seen, LBA’s assessment is that the existing risks (the risks involved in doing nothing) remain constant and with time increase marginally as the existing infrastructure elements in the NRT continue to age and degrade, while the in-service refurbishment risks gradually decline to a residual level. The spreadsheet that supports the chart below is provided in Ref 2 Appendix A10.9.

Figure 11-1: Comparison of Risk Profiles Existing vs Refurbishment

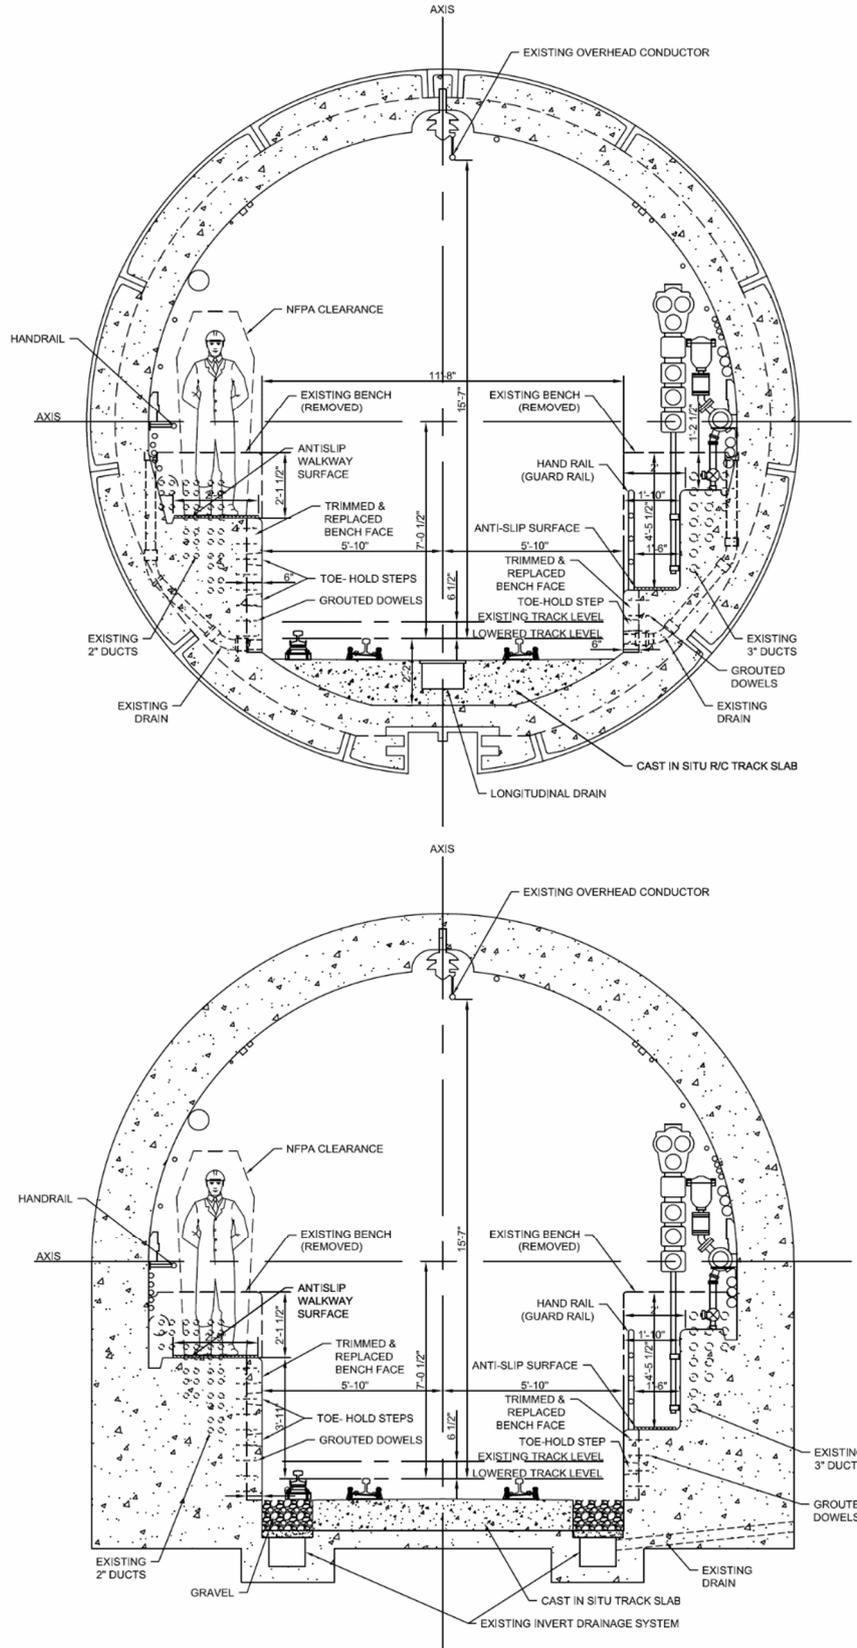
- Heavily labour intensive
- Likely to disturb and damage the portions of the existing benches that are intended to remain, particularly as a result of cold joints
- Likely to be slow to demolish and reinstate
- Difficult to achieve the required quality of finish
- Unlikely to achieve the required life expectancy
- Inadequate ducting remaining after reconstruction, particularly larger sizes
- Reliant on the condition of the existing ducts and drains

Figure A2.1: Re-profile & repair the existing concrete benches.

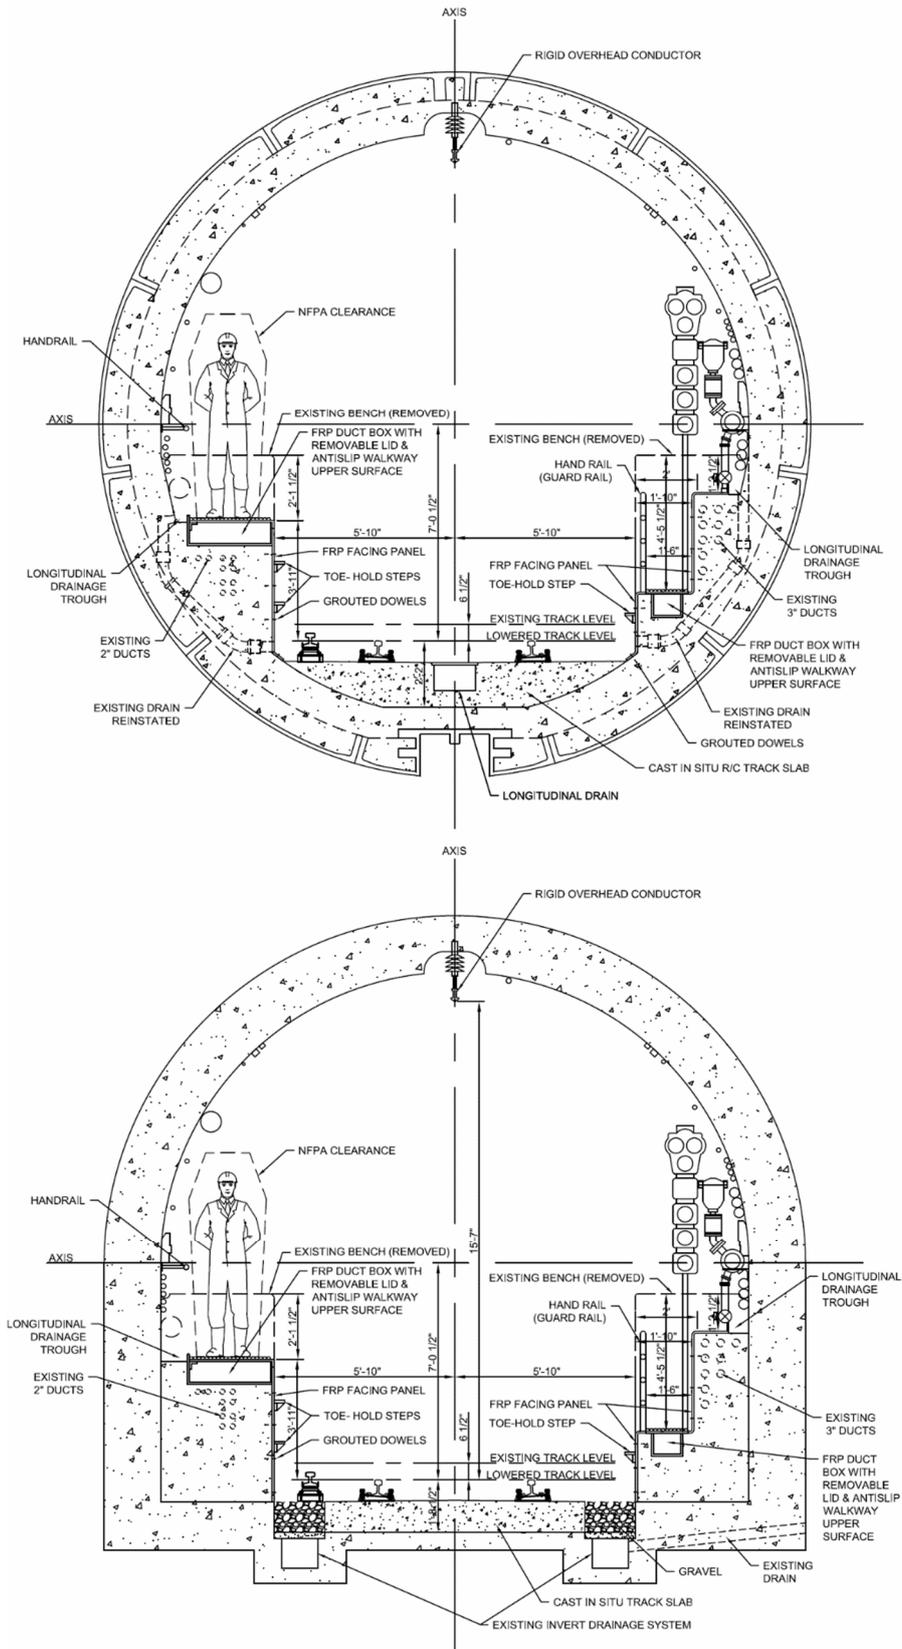
- Heavily labour intensive
- Likely to disturb and damage the portions of the existing benches that are intended to remain, particularly as a result of cold joints
- Likely to be slow to demolish and reinstate
- Difficult to achieve an accurate concrete profile which may require some reinstatement before FRP panels are fitted
- Reliant on the condition of the existing ducts and drains

Figure A2.2: Re-profile the existing concrete benches and clad with FRP panelling and cable ducts

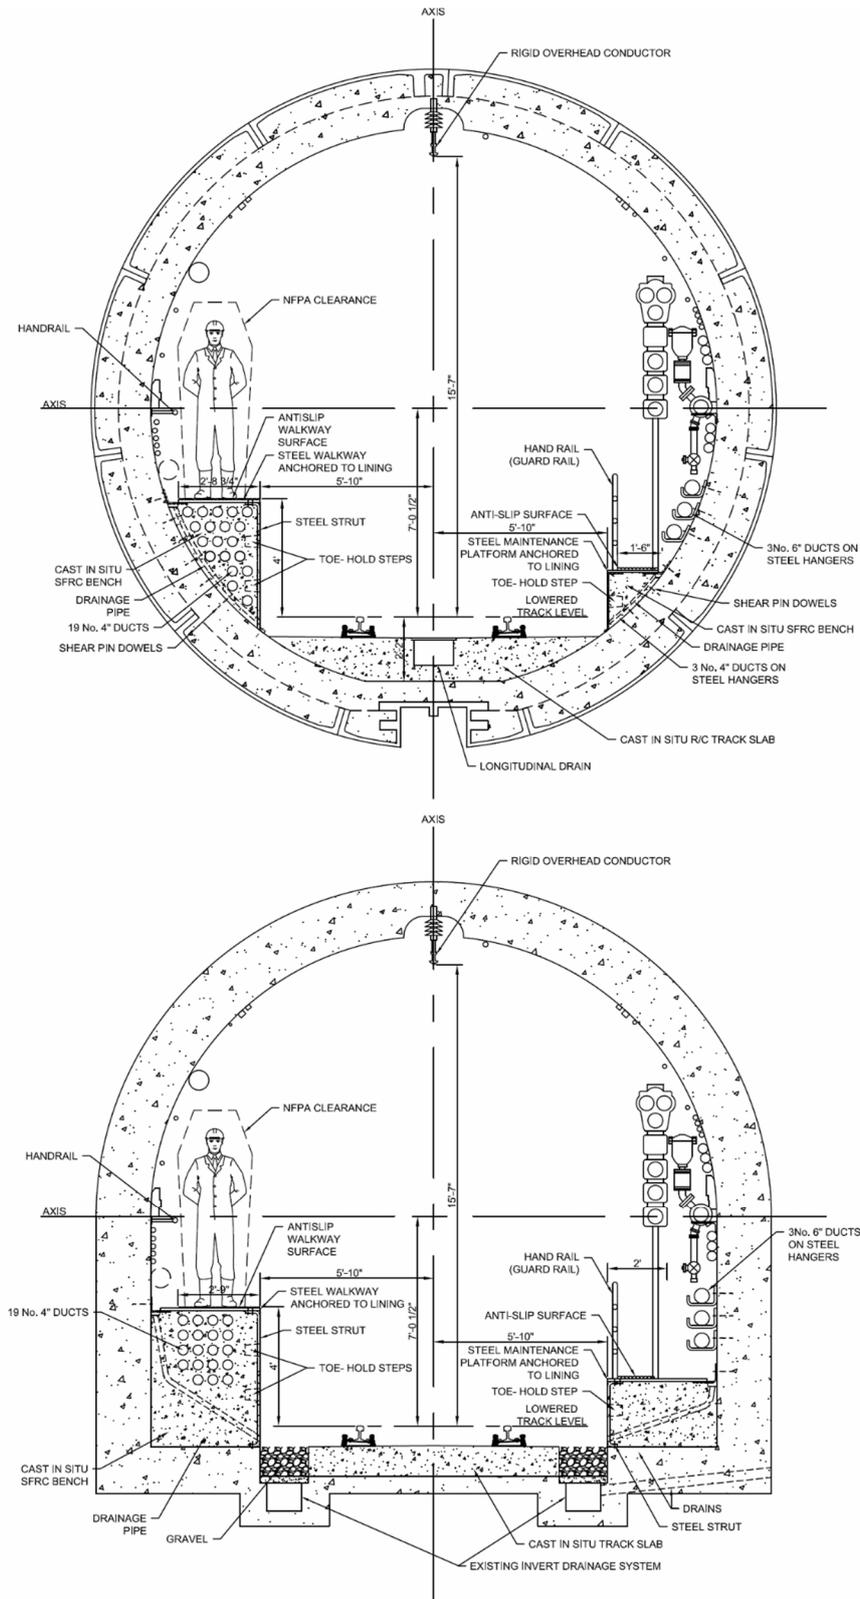
- No fire protection of cables in the open ducts mounted on hangers
- Some labour-intensive activities requiring hand tools
- Possible damage to the tunnel lining behind the benches during demolition

Figure A2.3: Demolish the existing concrete benches and replace with steel walkways and maintenance platforms then cast new concrete benches below.

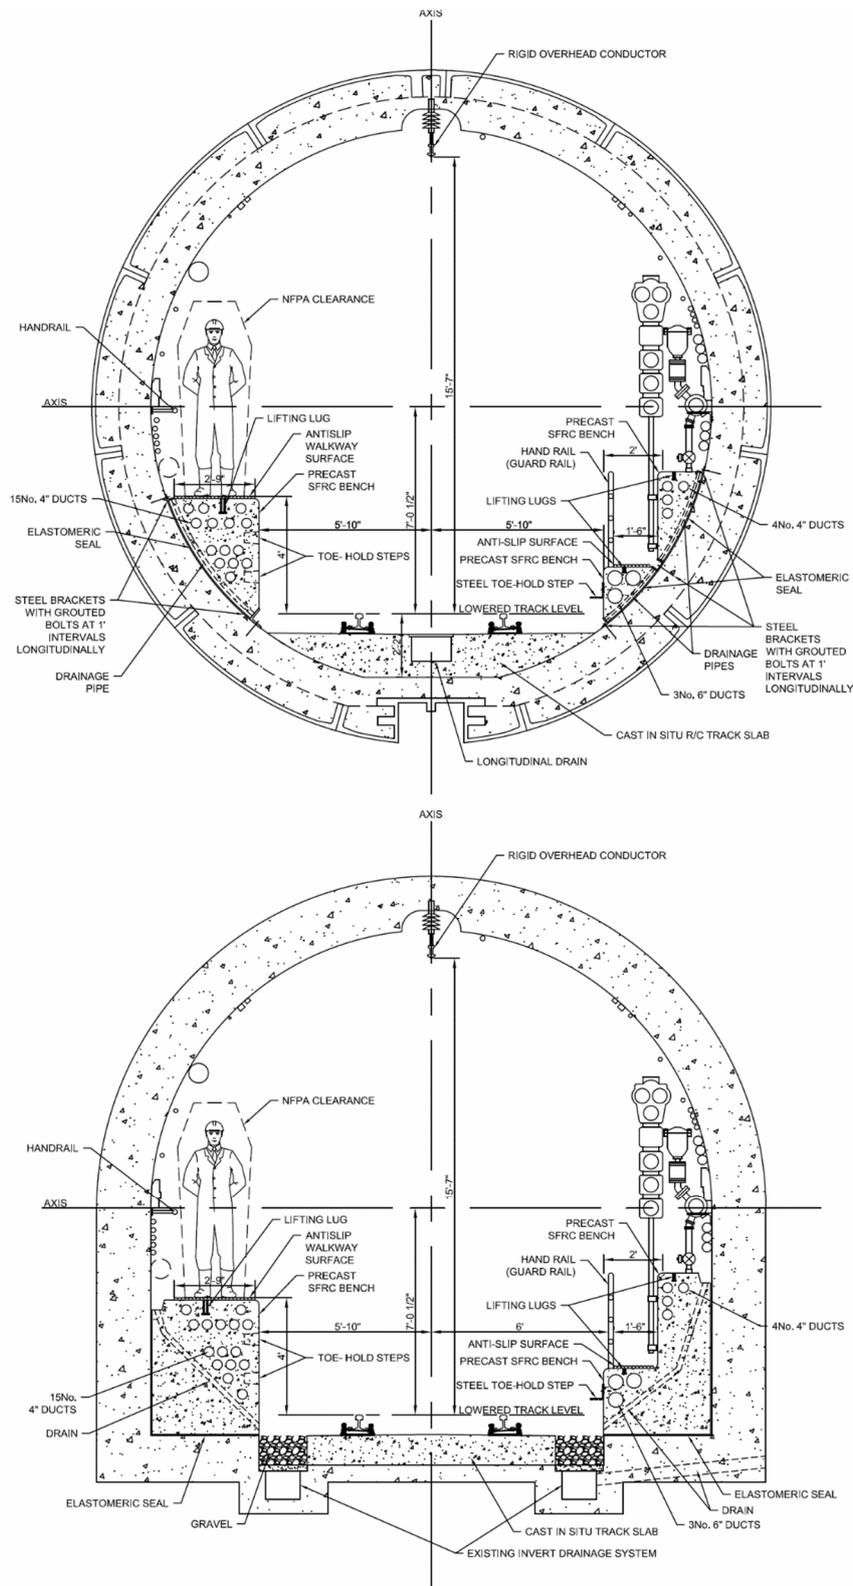
- HV cables will be pulled in short lengths not laid in long lengths

Figure A2.4: Demolish existing concrete benches & replace with pre-cast SFRC benches

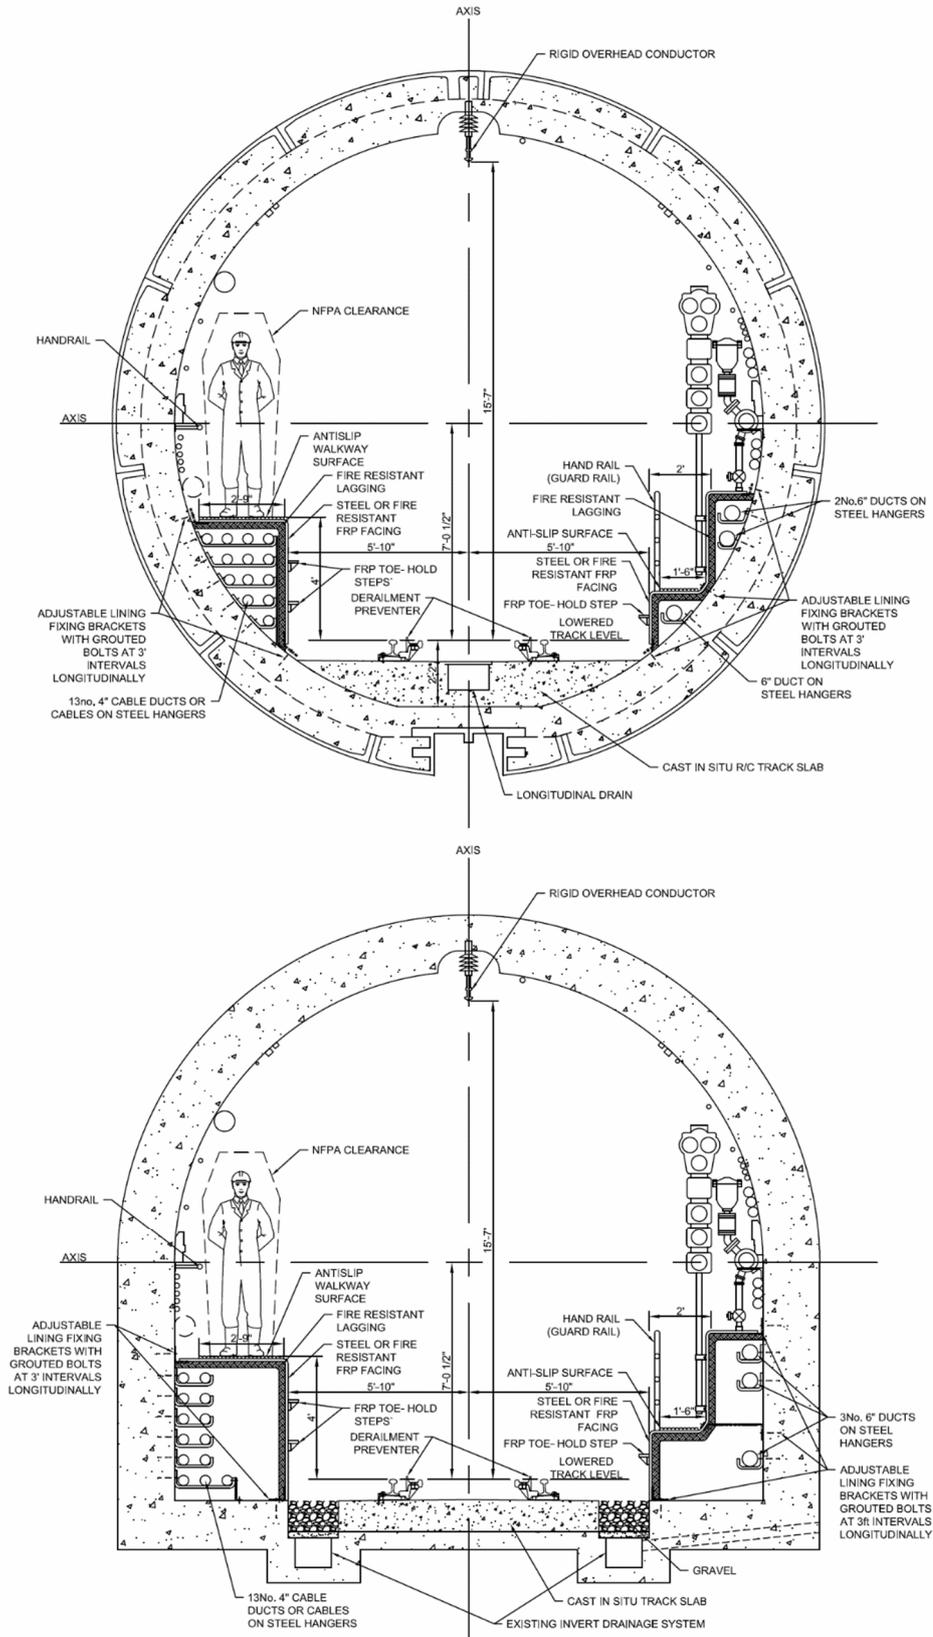
- May be insufficient space in the bored tunnel section to carry all of the required cable ducts
- May require anti-derailment in the track bed
- Some labour-intensive activities requiring hand tools
- Possible damage to the tunnel lining behind the benches during demolition
- Re-profiling and possible repair of the tunnel lining required before installation of the duct hanger frame and box units
- GRP may lose structural strength during a severe fire
- HV cables will be pulled in short lengths not laid in long lengths

Figure A2.5 Demolish the existing concrete benches & replace with fire resistant GRP or steel boxes & conventional ducts mounted on steel hanger brackets
