GATEWAY PROGRAM DEVELOPMENT CORPORATION RELEASES INDEPENDENT ANALYSIS OF NORTH RIVER TUNNEL REHABILITATION

Conceptual study by London Bridge Associates believes that full rehabilitation of tunnel “in-service” with the same scope and useful life, in conjunction with construction of new tunnel may be feasible and improved customer experience may be possible sooner if a number of pre-construction activities are undertaken immediately and expedited to completion. GDC and Partners to consider recommendations.

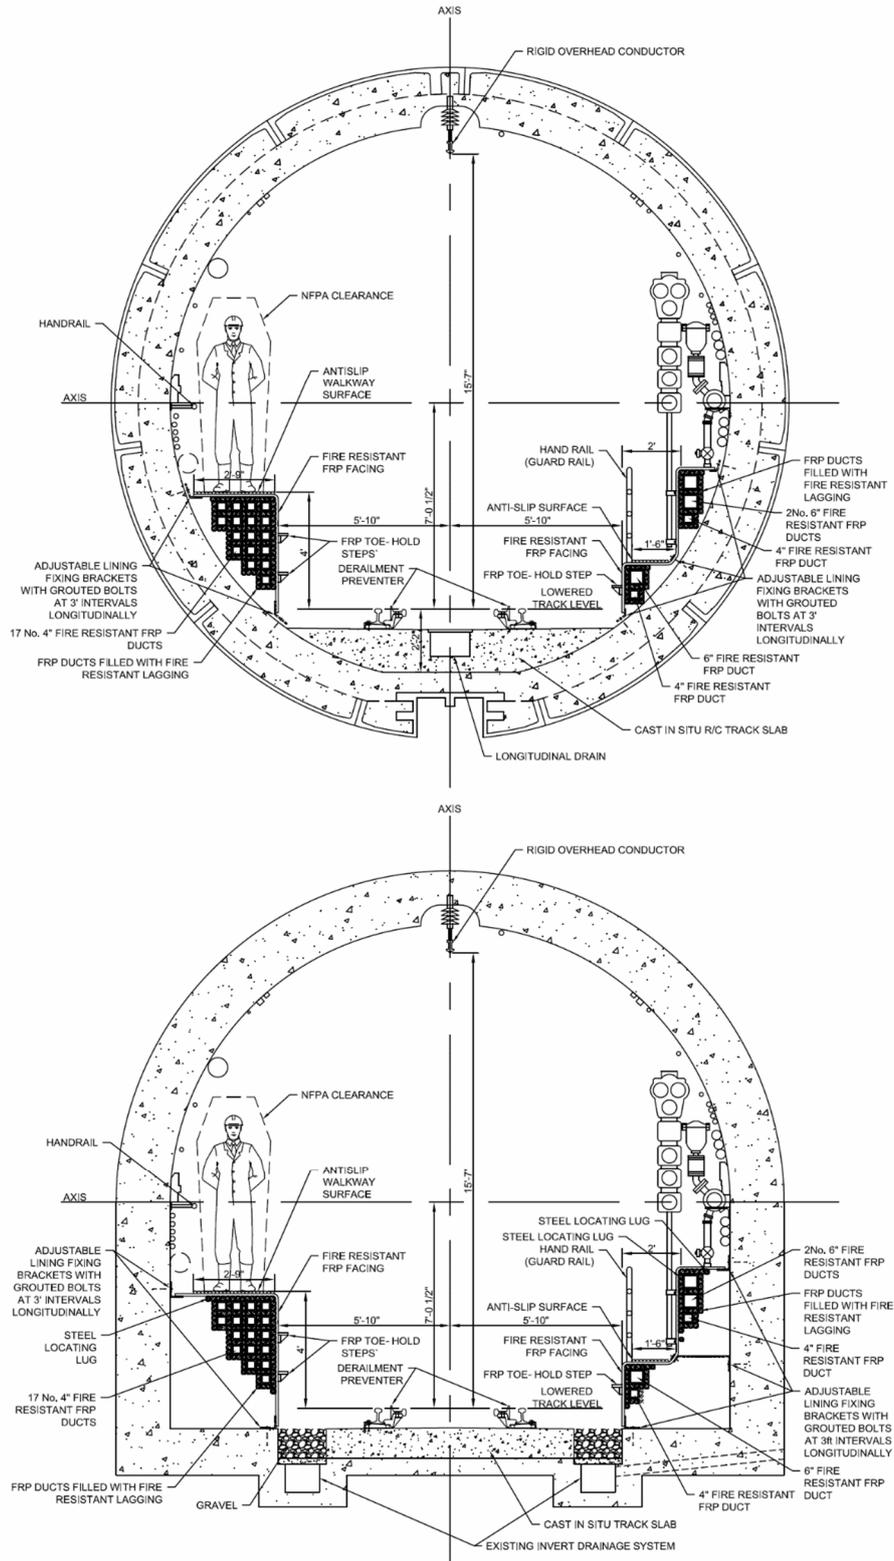
- May lose structural strength during a severe fire
- May be difficult to install new units if badly damaged
- May require anti-derailment in the track bed
- Some labour-intensive activities requiring hand tools
- Possible damage to the tunnel lining behind the bench walls during demolition.
- Re-profiling and possible repair of the tunnel lining required before installation of the GRP box units
- HV cables will be pulled in short lengths not laid in long lengths

Figure A2.6: Demolish the existing concrete benches & replace with fire-resistant bench facings and ducts

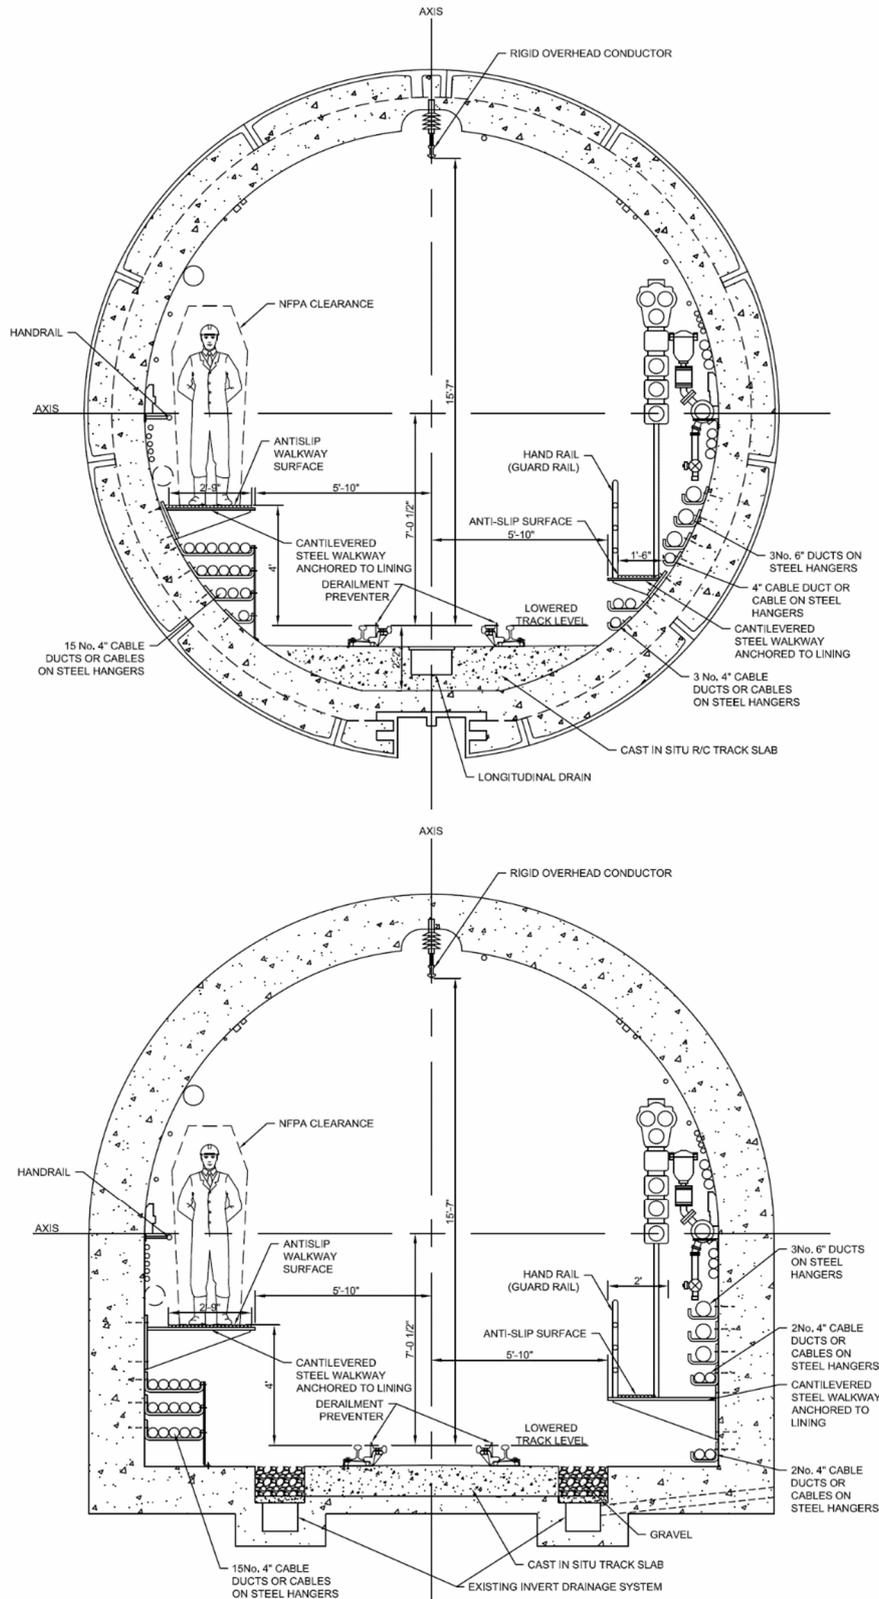
- No fire protection of exposed cables or cables in ducts
- May require anti-derailment in the track bed
- Some labour-intensive activities requiring hand tools
- Possible damage to the tunnel lining behind the bench walls during demolition
- Re-profiling and possible repair of the tunnel lining required before installation of the hangers, walkway and maintenance platform

Figure A2.7: Demolish the existing concrete benches & replace with cantilevered steel walkways & conventional ducts mounted on steel hanger brackets (note that the P/C track slab includes anti-derailment measures).

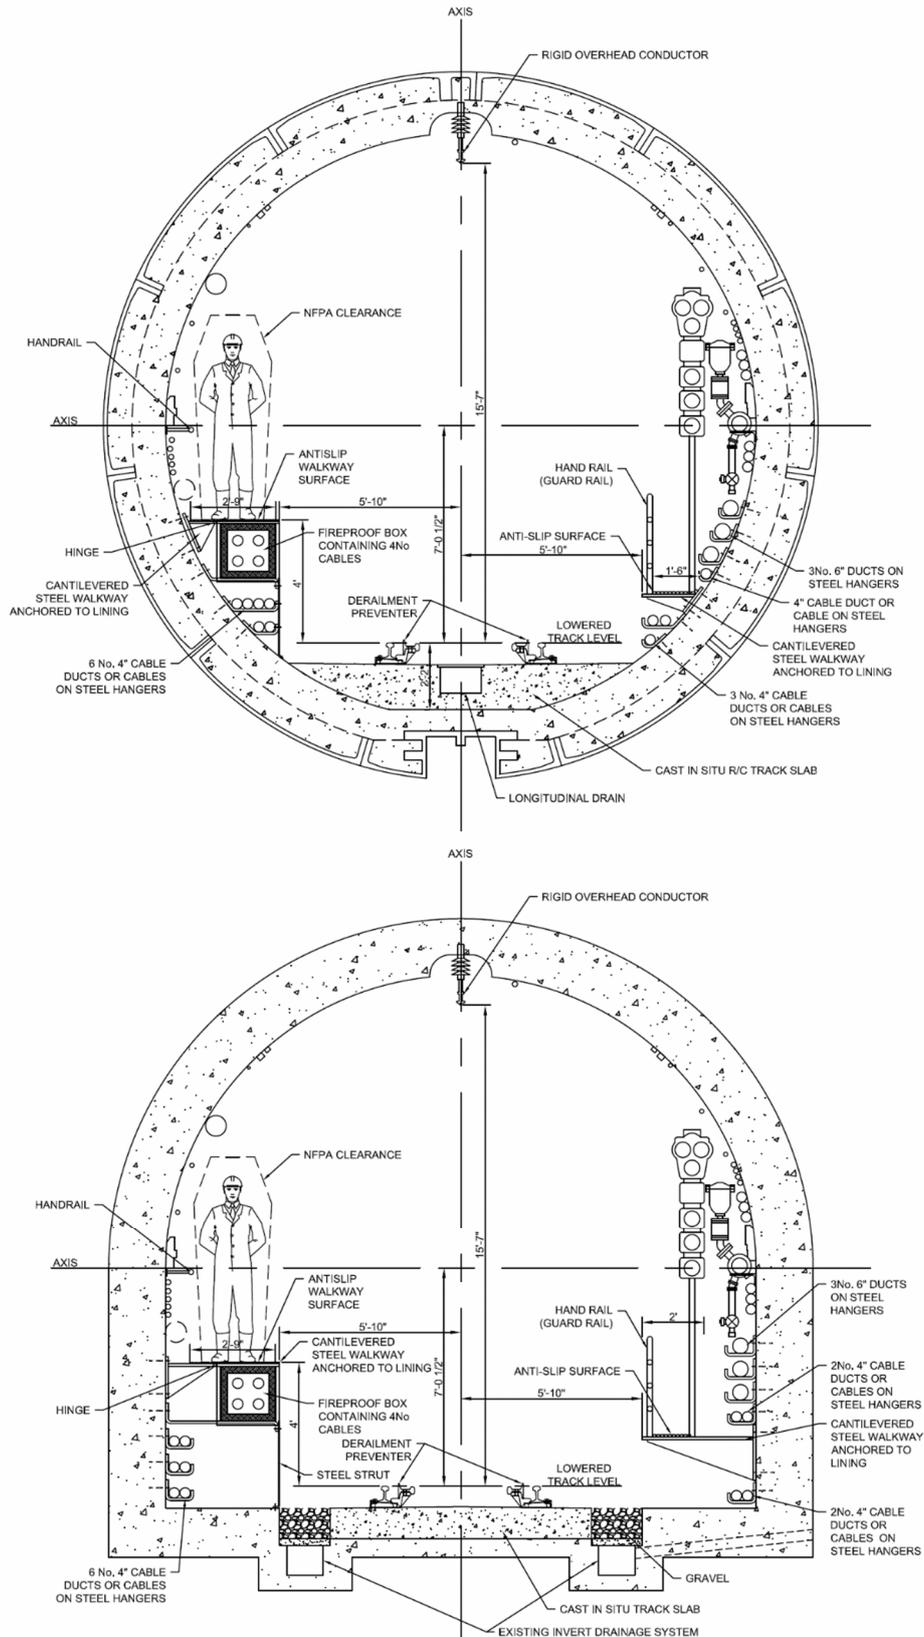
- May be insufficient space in the bored tunnel section to carry all of the required cable ducts
- No fire protection of cables or cable ducts mounted on hangers
- May require anti-derailment in the track bed
- Some labour-intensive activities requiring hand tools
- Possible damage to the tunnel lining behind the bench walls during demolition
- Re-profiling and possible repair of the tunnel lining required before installation of the duct hangers, walkway and maintenance platform

Figure A2.8: Demolish the existing concrete benches and replace with steel walkways and maintenance platforms with cables or cable ducts mounted on steel hanger brackets with critical cables contained in a fire-proof box below the walkway.

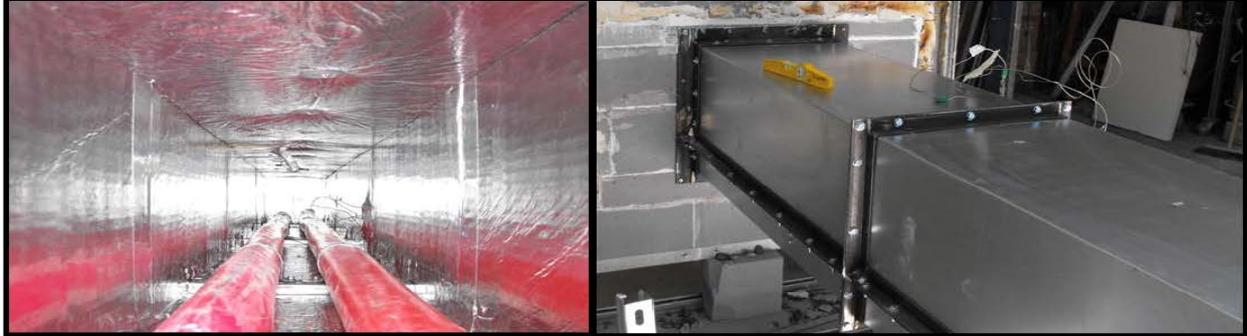
An example of suitable fire resistant cable ducting is the Flamebar BW18 fire resistant HV cable enclosure, which was developed to meet standard BS8519: 2010, "*Inclusion of new and revised technical guidance relating to the selection and installation of fire resistant cables and systems for life safety and fire-fighting applications.*" and is shown in Figure A2.9 below:

Figure A2.9 This is one example of a ducting system which could be used if it is required.

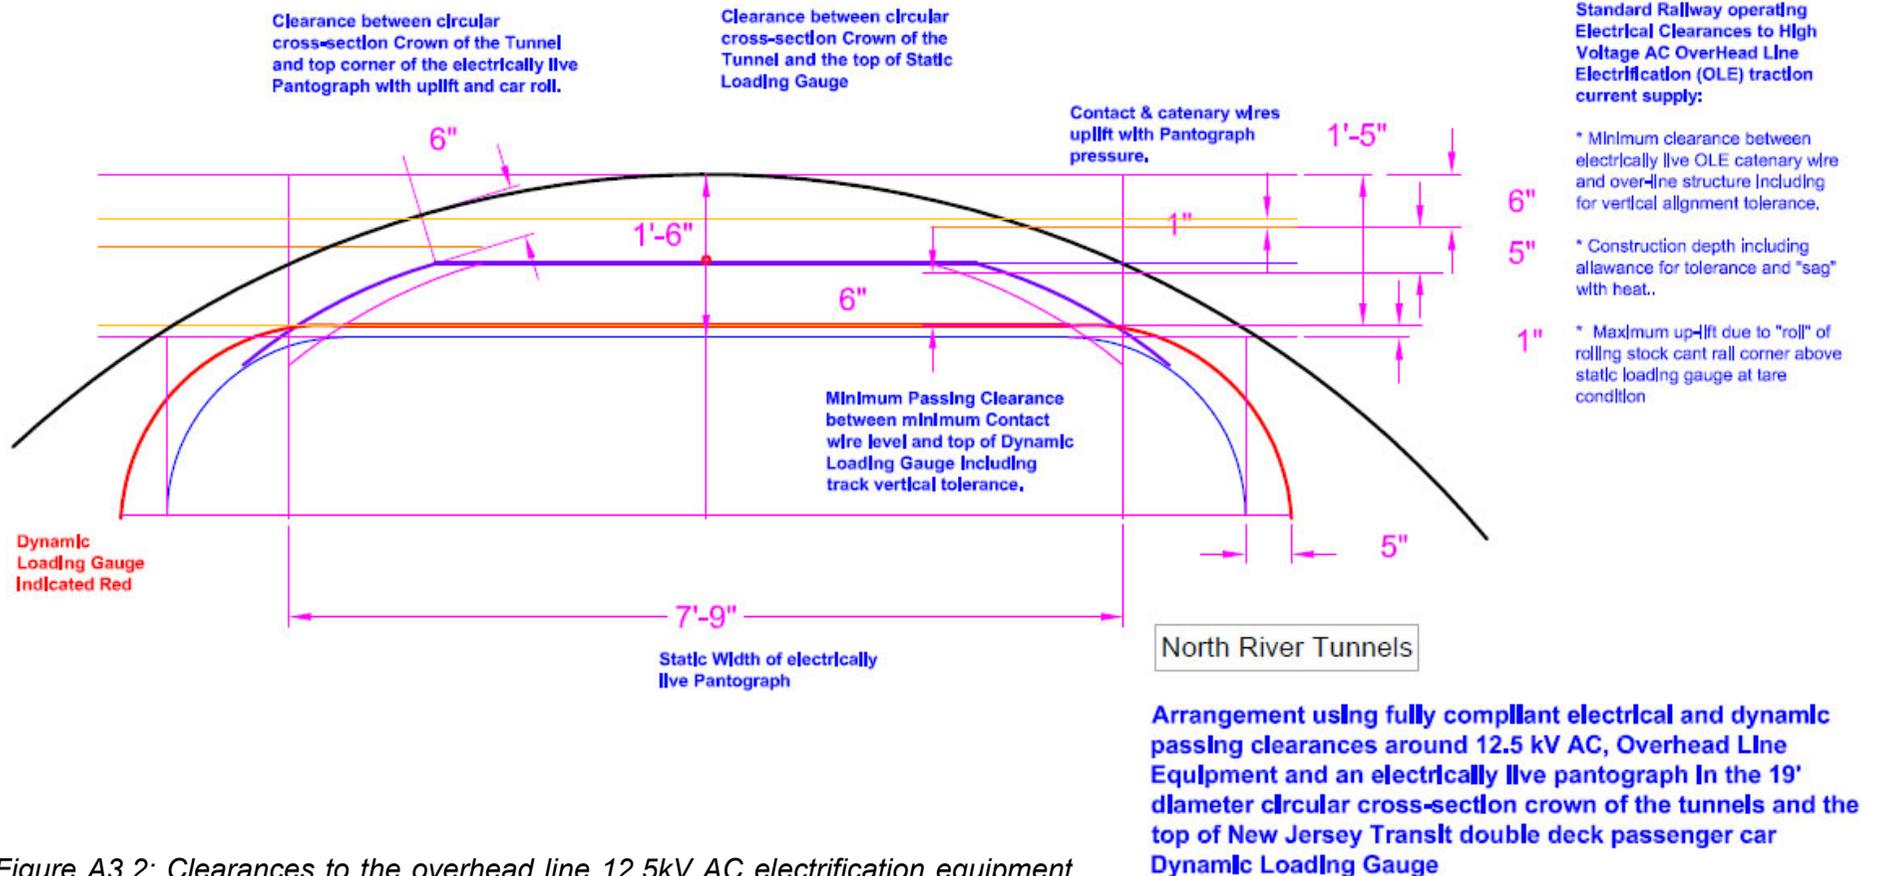
Figure A3.2: Clearances to the overhead line 12.5kV AC electrification equipment (OLE) and rail vehicle pantograph

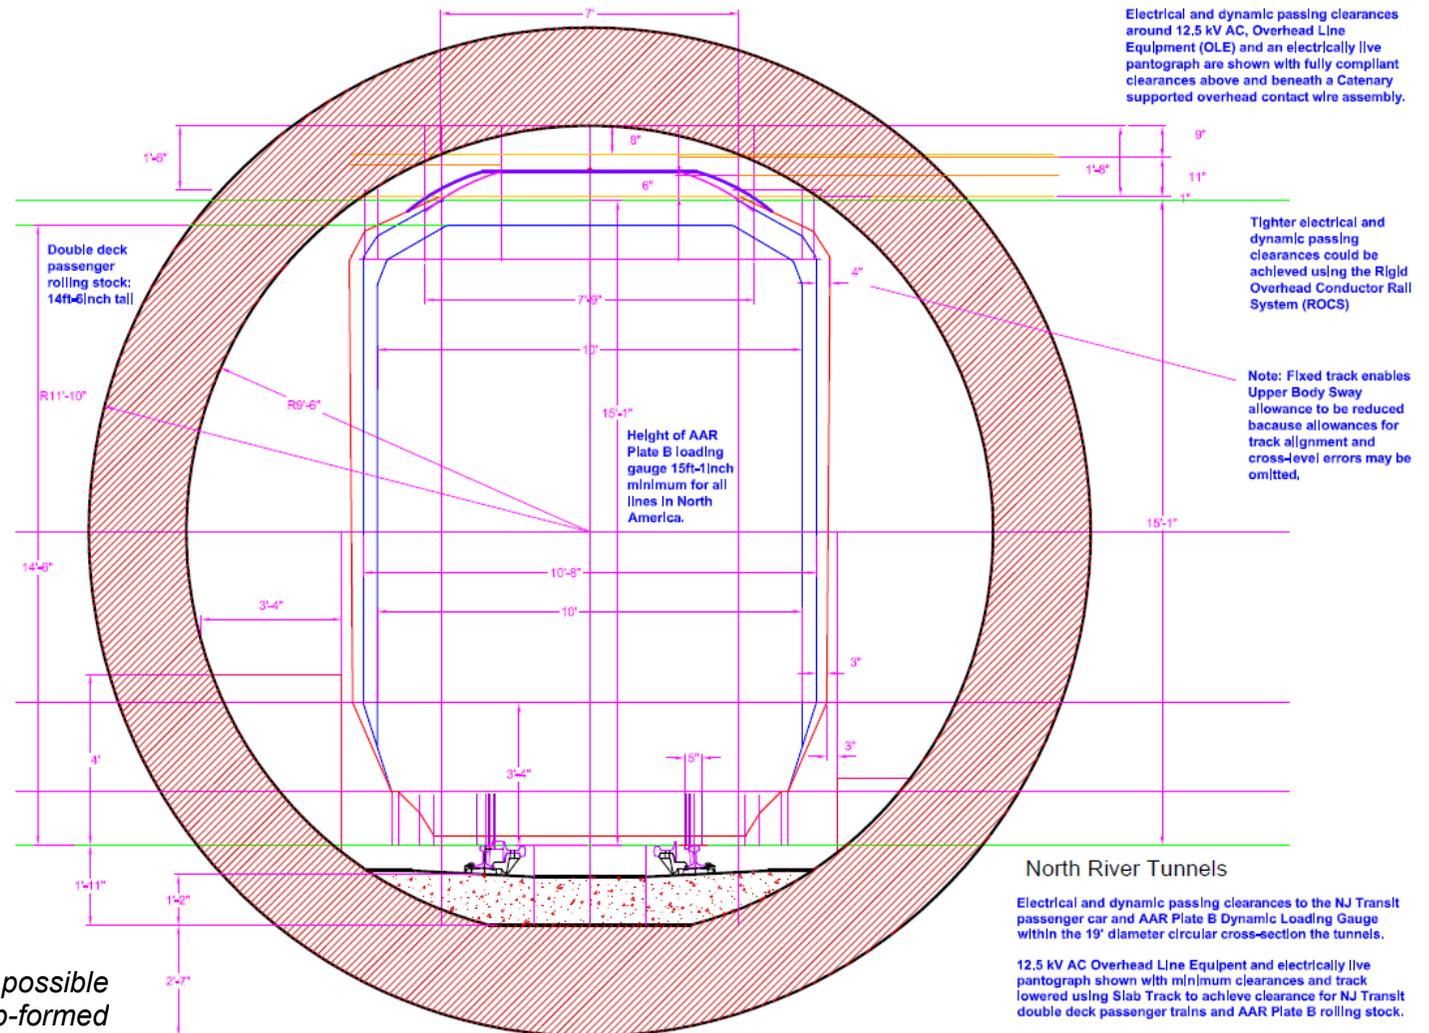
Figure A3.3: Track lowering and possible arrangement for slip-formed slab track

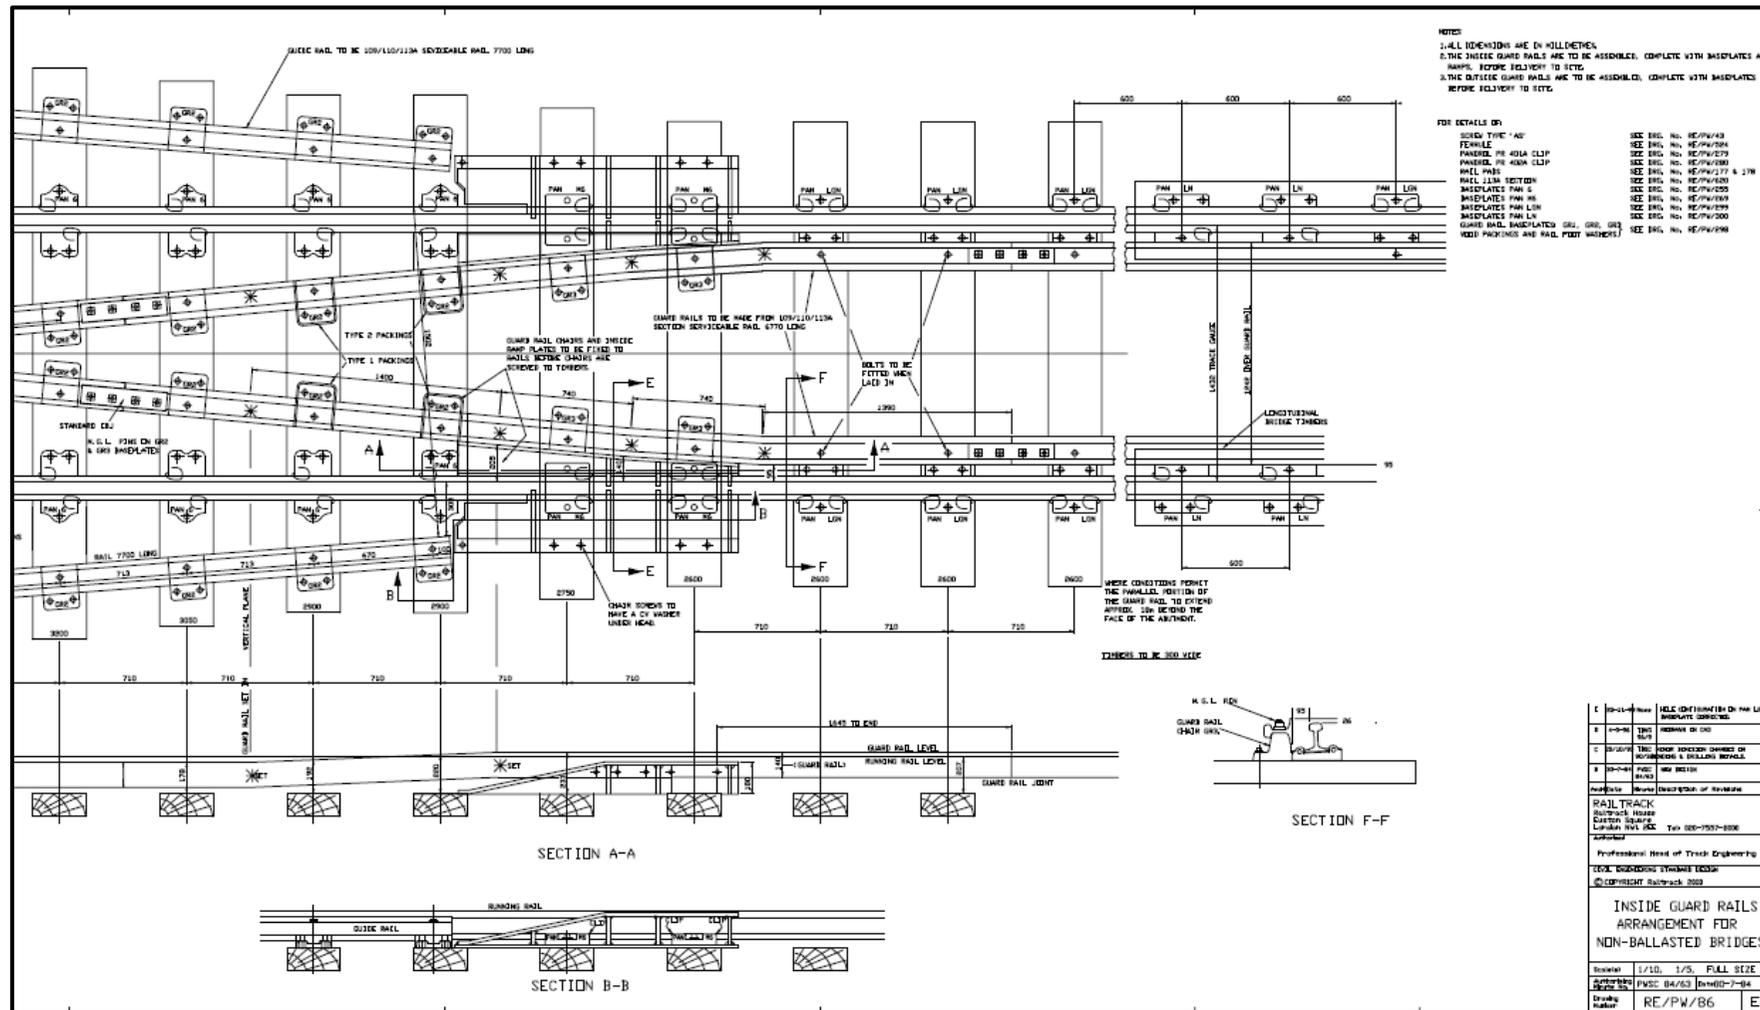
Figure A3.4: Continuous Checking Guard Rail

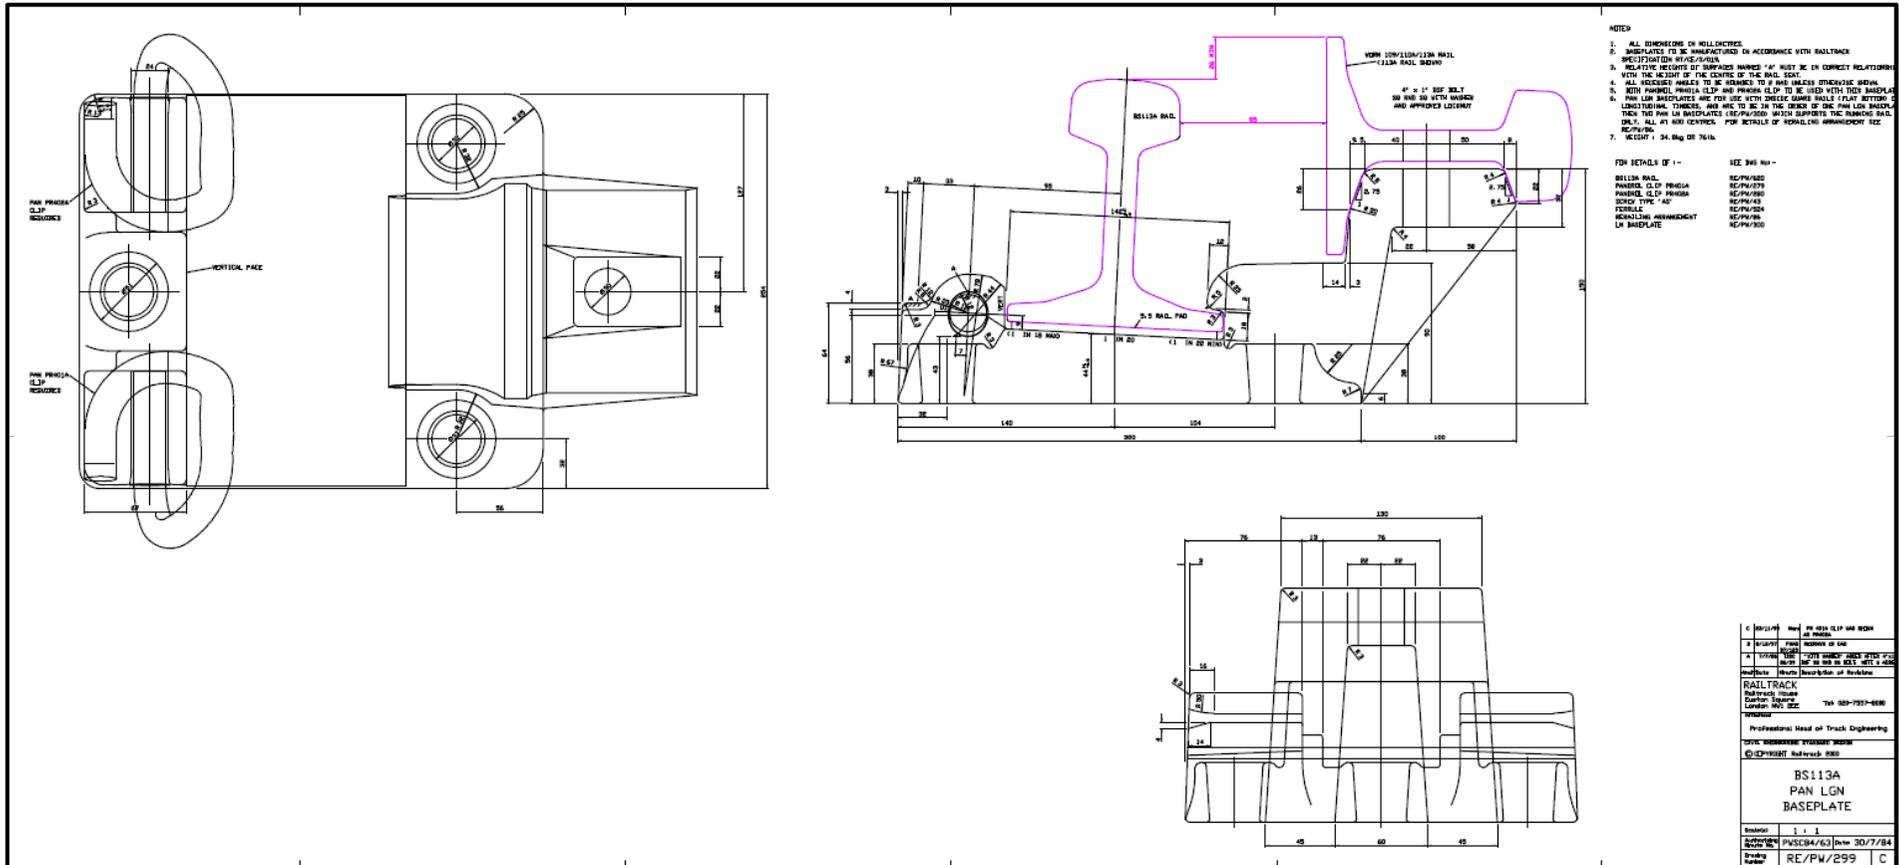
Figure A3.5: Baseplate

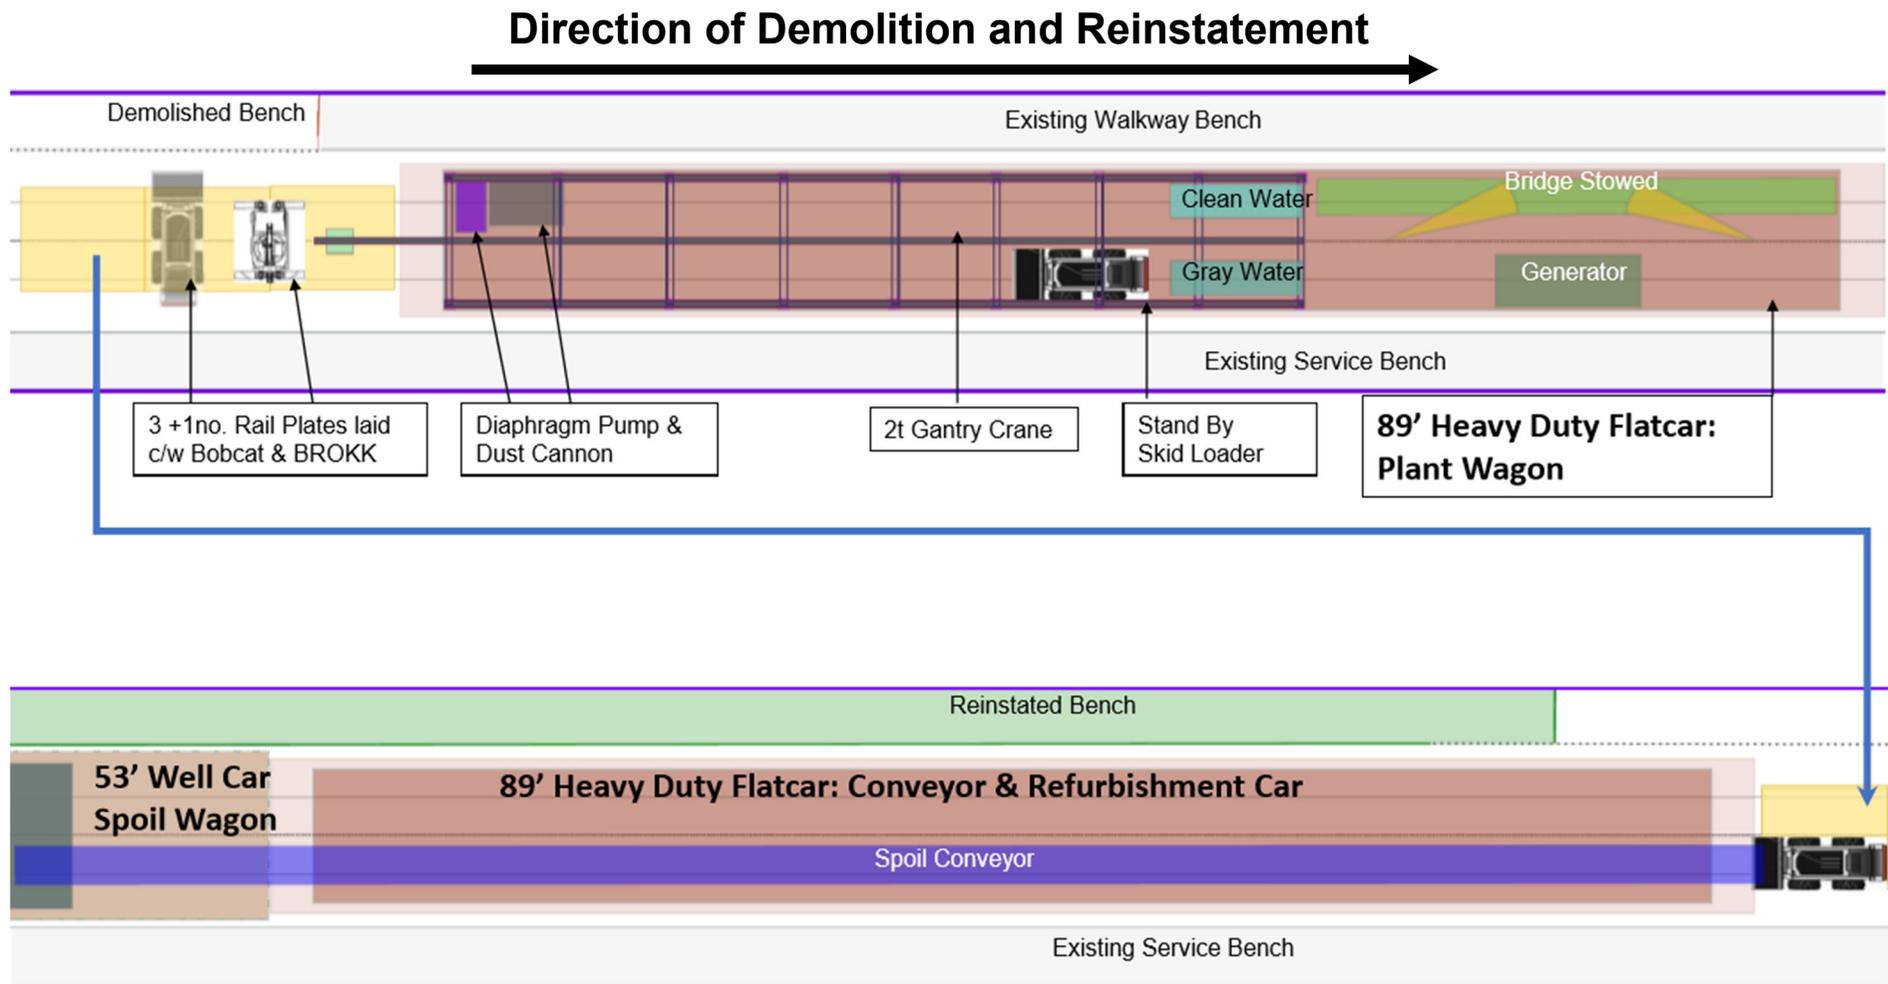
Figure A4.1 – Works train in operational mode

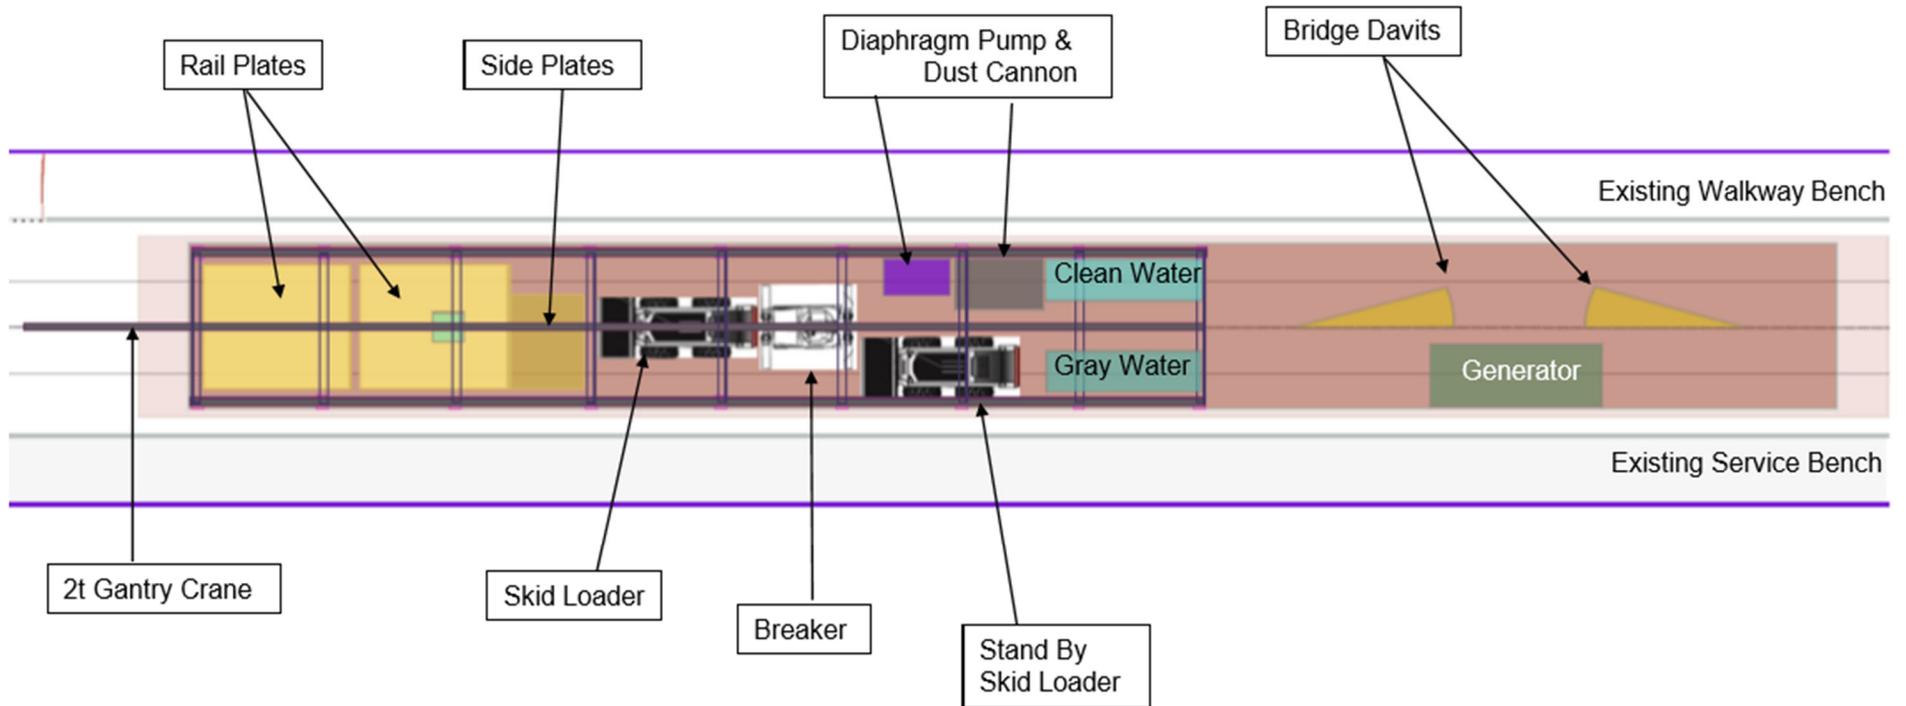
Figure A4.2 – Plant car in transit mode

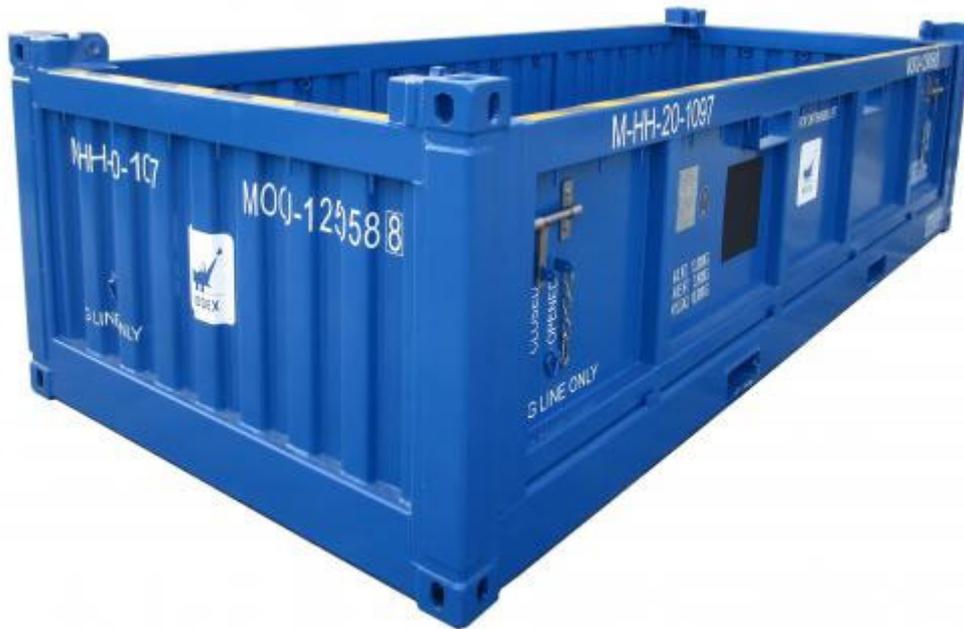
Figure A4.4 - 53' Well Car

These containers, which are made mostly of steel, are half the height of full-sized containers. They are used especially for coal, stones etc., which need easy loading and unloading.

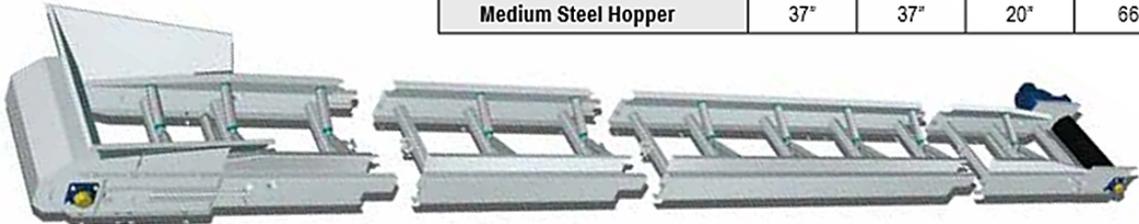
EASIKIT

EK600 SECTIONS	Length (in)	Width (in)	Height (in)	Weight (lb)
Head Unit without motor (H)	59 1/2"	36 1/2"	11 1/2"	188
Head Unit with 3kW motor	60"	40"	12"	265
Base Tension Unit (T)	60 3/4"	30"	11 1/2"	180
4' (1.2m) Section	53"	24 1/2"	11 1/2"	90
8' (2.4m) Section	100 1/2"	24 1/2"	11 1/2"	175
Small Steel Hopper	31"	33 1/2"	12"	35
Medium Steel Hopper	37"	37"	20"	66

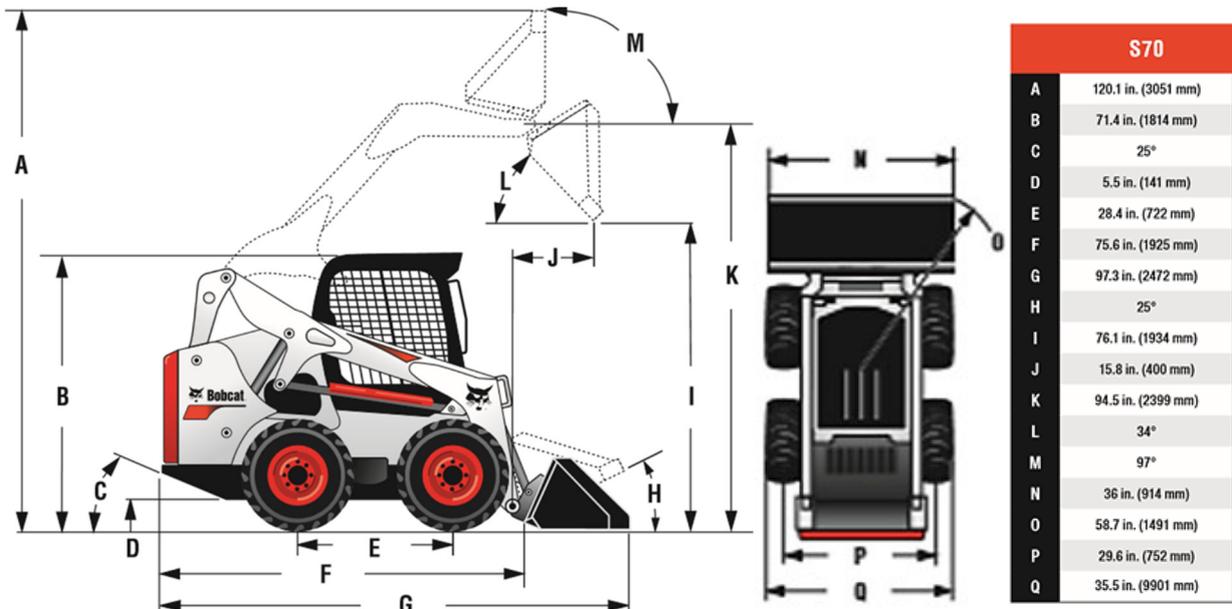
Figure A.7. - Skid Steer Loader

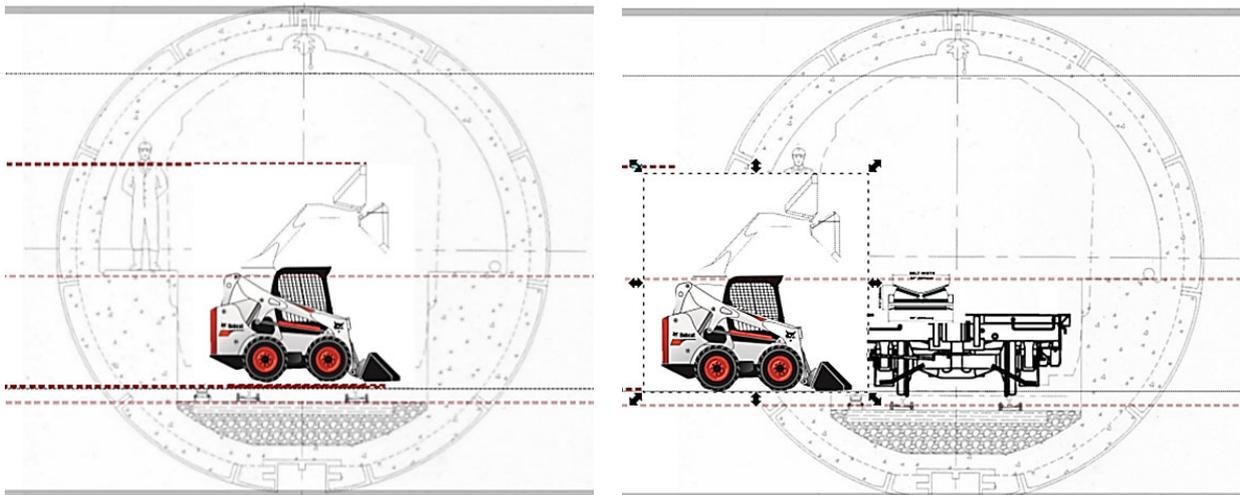
Figure A4.8. - Skid Steer Loader

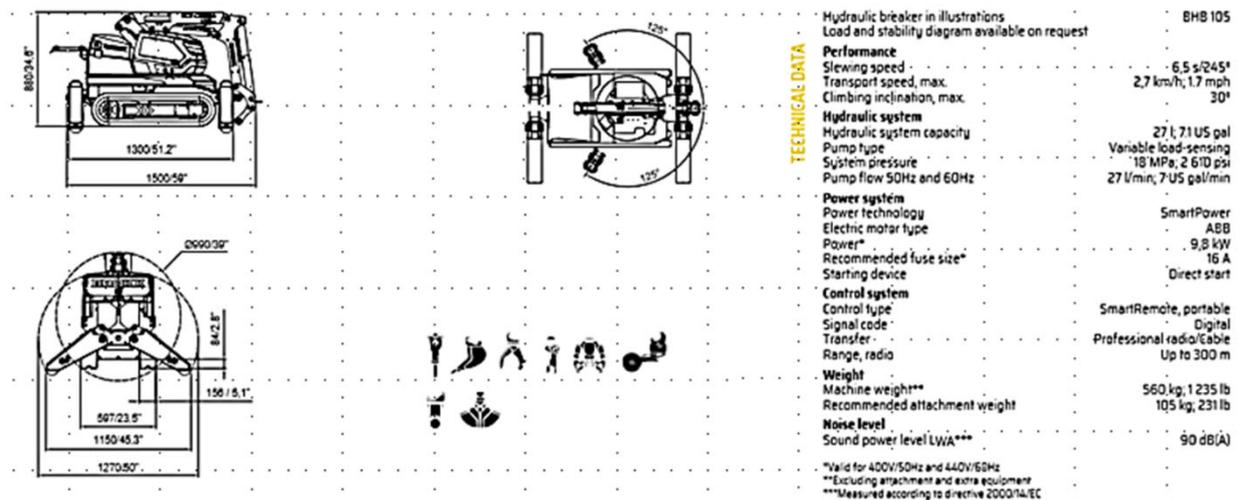
Figure A4.9. - Brokk 70 Breaker and Trimmer

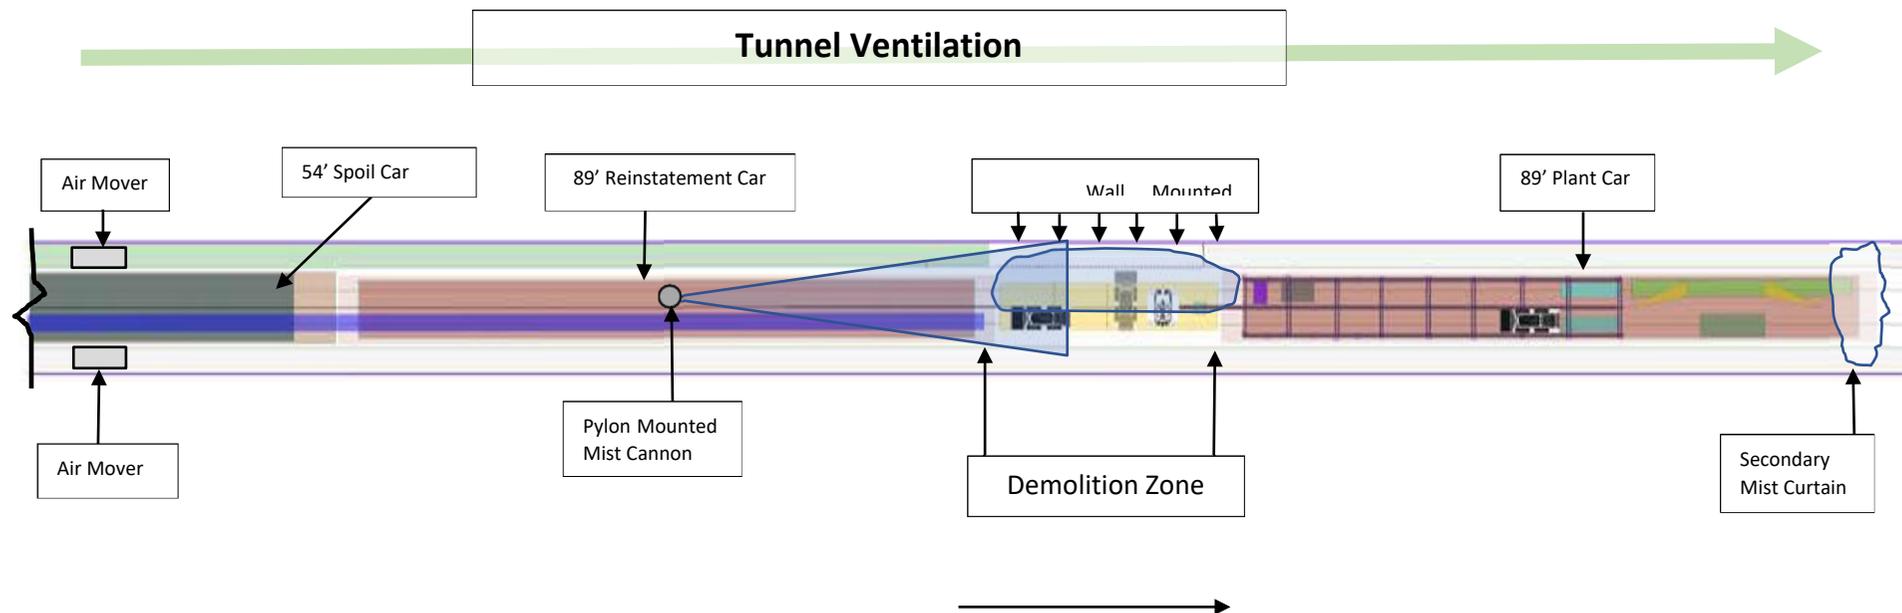
A5.3 Sketch-up of Dust Control Measures

- Activities to be covered by dust suppression mist cannon and sprinklers.
- Concrete drilling and chipping with handheld power tools
- Tools to be equipped with shroud and dust collection system or water delivery system.
- Personnel Protective Equipment
- All personnel to use Assigned Protection Factor 10 Respiratory Protection

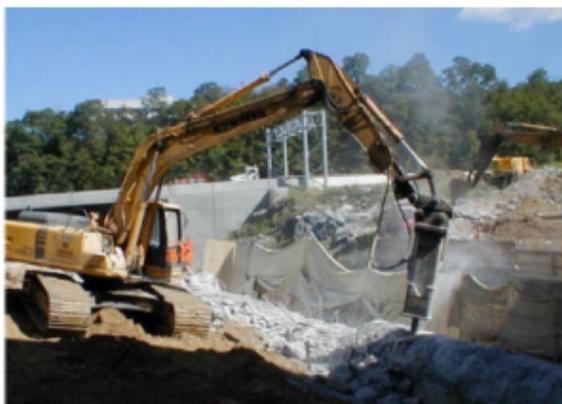
Excavator equipped with an enclosed cab and hoe-ram demolishing a concrete wall.

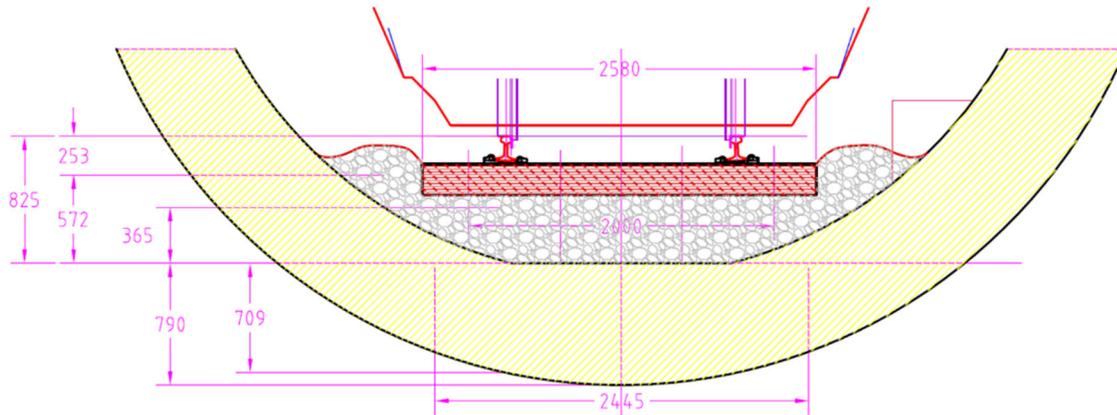
Stage 0: Existing track on base plates and timber cross-ties. 3rd rail to be removed before commencement of track renewal. Not shown here with guard-rail base plates but could be added from this stage).

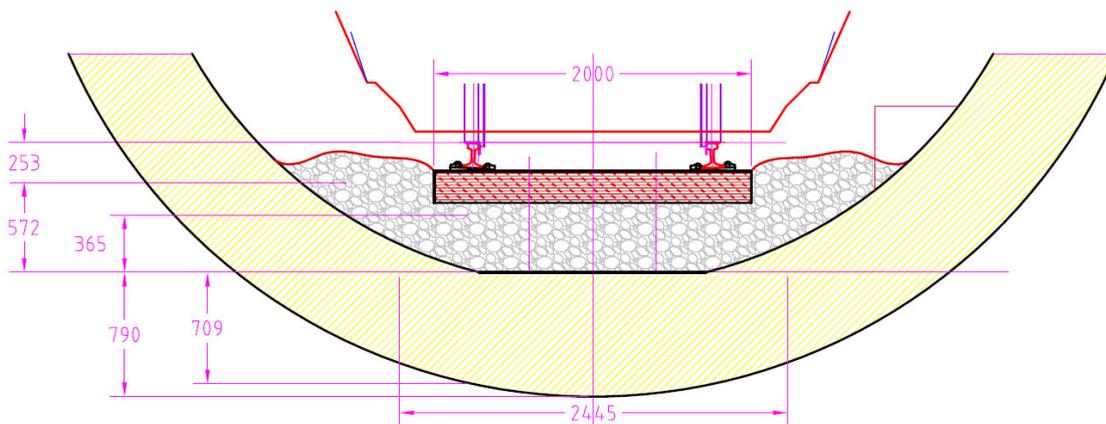
Stage 1: Timber cross-ties shortened by 24 inches.

Additional ballast at shoulders to ensure track alignment

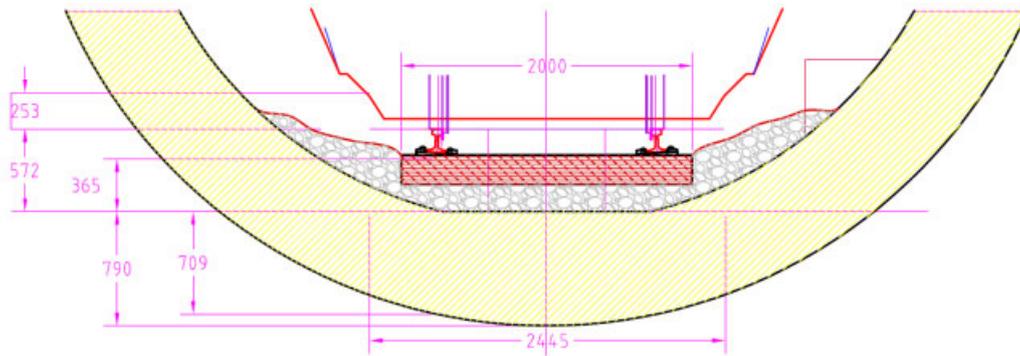
Stage 2: Track lowered to new designed level Excess ballast removed during several passes by Ballast Cleaner machine 95mm minimum clearance timber cross-tie to intrados.

This shows one example only of a replacement track bed, but other designs are equally achievable.

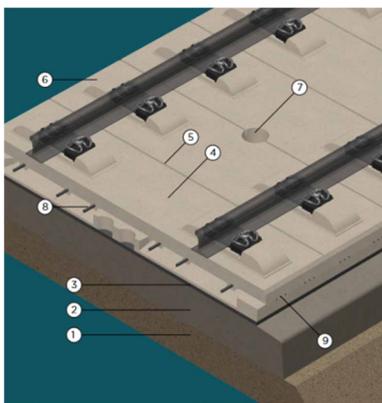
Typical Precast Slab Track System

- 1 FROST PROTECTION LAYER (FSS)
- 2 HYDRAULICALLY BOUND LAYER (THB), D = 30 CM
- 3 GROUTING MASS
- 4 SLAB TRACK
- 5 DESIGN CRACKING JOINT
- 6 RAIL SUPPORT POINT
- 7 OPENING FOR GROUTING MASS
- 8 GEWI STEEL
- 9 PRESTRESSED STEEL
- 10 TURNBUCKLES AND NUTS
- 11 CONSTRUCTION JOINTS

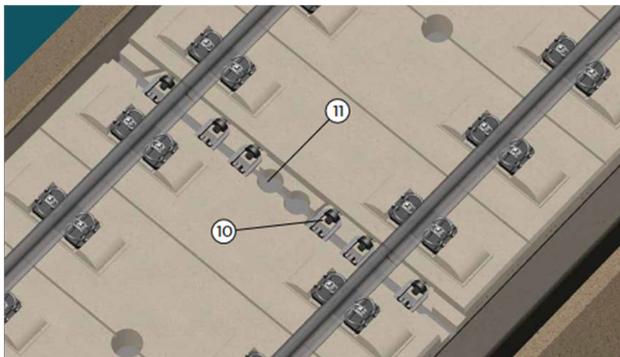
Construction height (from OK THB to OK rails):	474 mm
Slab length (System length: nominal 6.5 m):	6,45 m
Slab width:	2,55 m
Slab height:	0,20 m
Rail supports:	10 pairs per slab; spacing 650 mm
Prestressing:	transversal
Longitudinal coupling:	GEWI steel

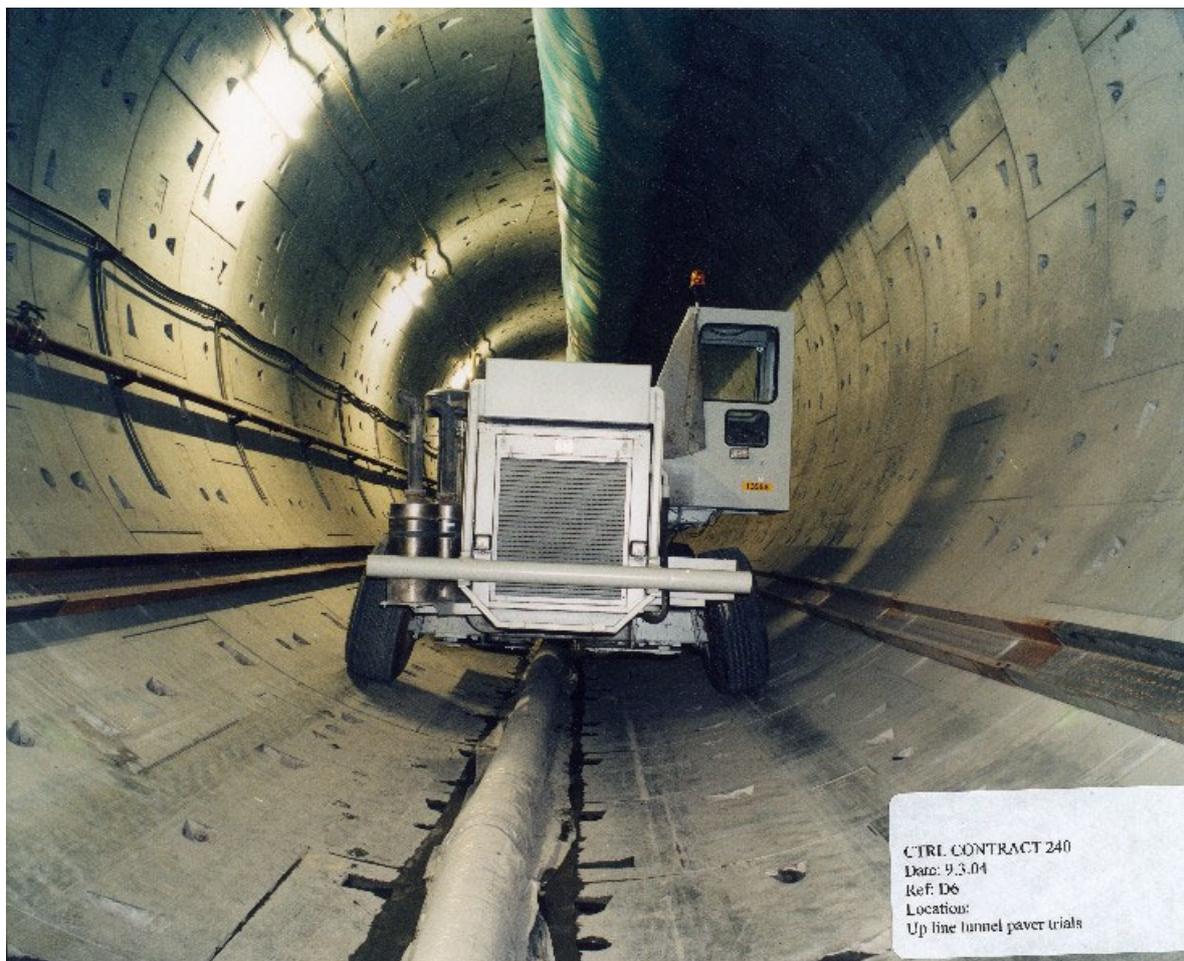
Figure A6.1 Gomaco paver getting ready to provide stage 1 track bed on High Speed 1 in the UK
