GATEWAY PROGRAM DEVELOPMENT CORPORATION RELEASES INDEPENDENT ANALYSIS OF NORTH RIVER TUNNEL REHABILITATION

Conceptual study by London Bridge Associates believes that full rehabilitation of tunnel “in-service” with the same scope and useful life, in conjunction with construction of new tunnel may be feasible and improved customer experience may be possible sooner if a number of pre-construction activities are undertaken immediately and expedited to completion. GDC and Partners to consider recommendations.

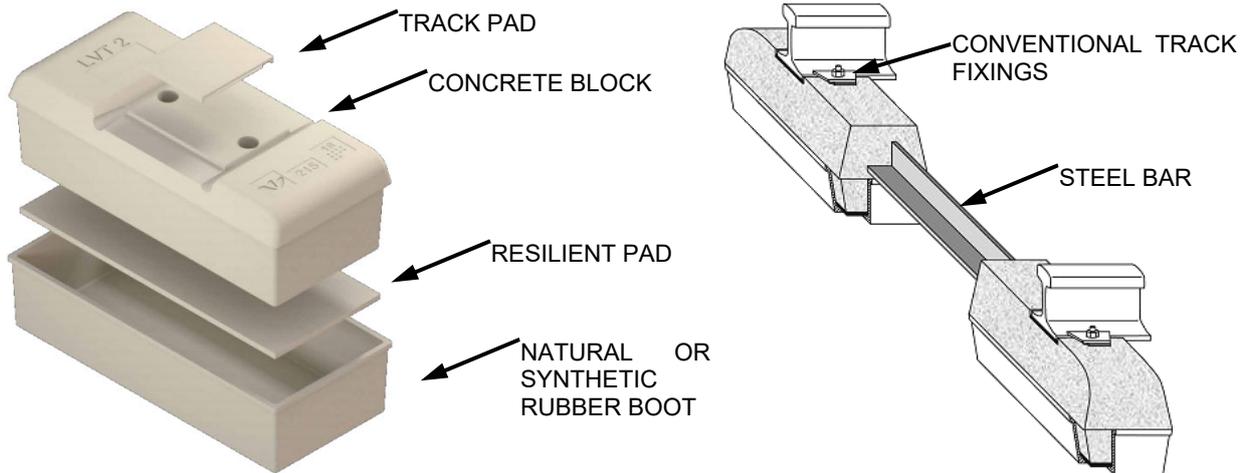
Figure A6.2 Key elements of the booted track tie system

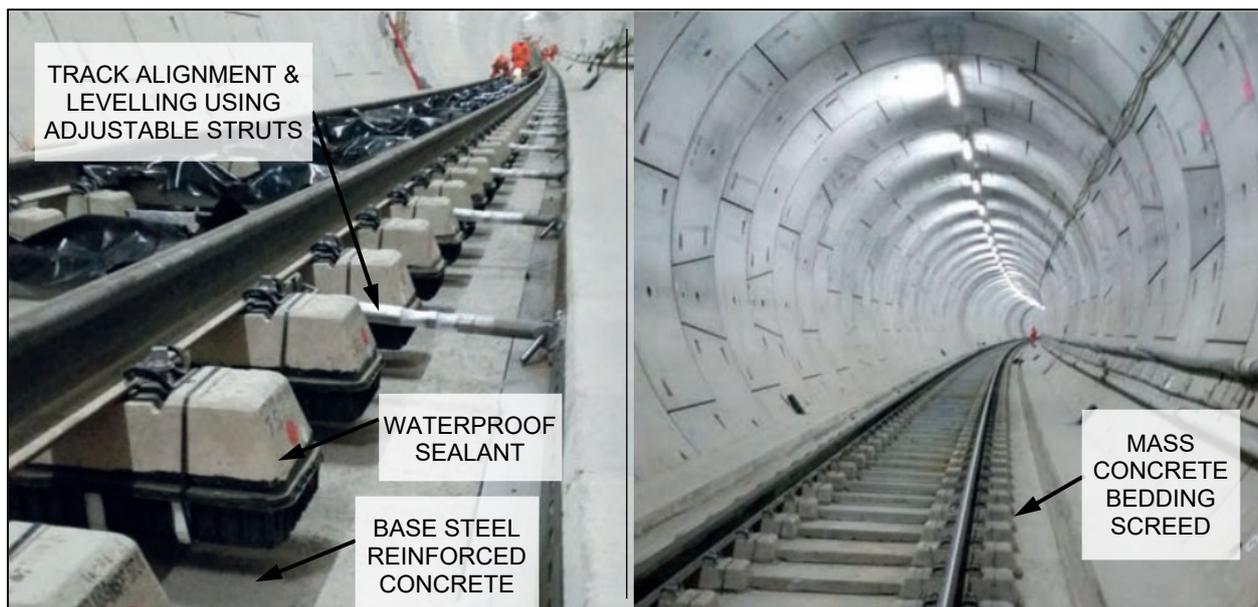
Figure A6.3 Crossrail tunnels, London, UK. - Setting out of booted sleeper track (above left) above the steel reinforced cast concrete base before the second stage mass concrete screed bedding is poured above (right). Above final checking of alignment.

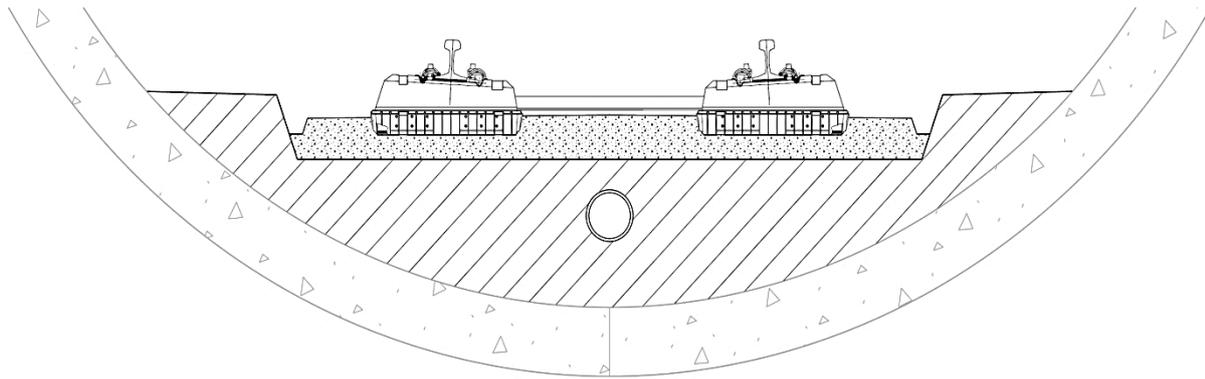
Figure A6.4 Crossrail tunnels, London, UK. – Track slab and booted track ties design.

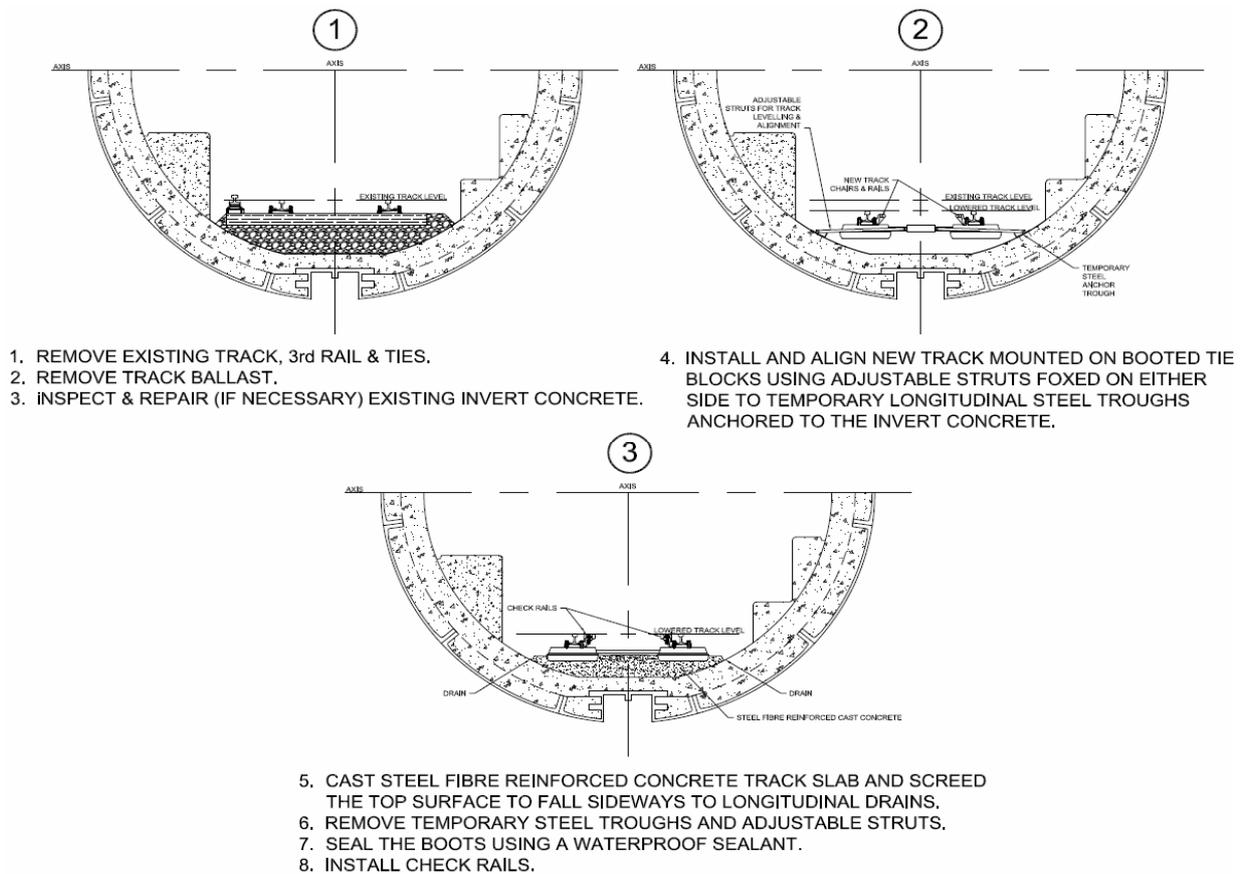
Figure A6.5 Construction Sequence Track bed with booted cross ties.

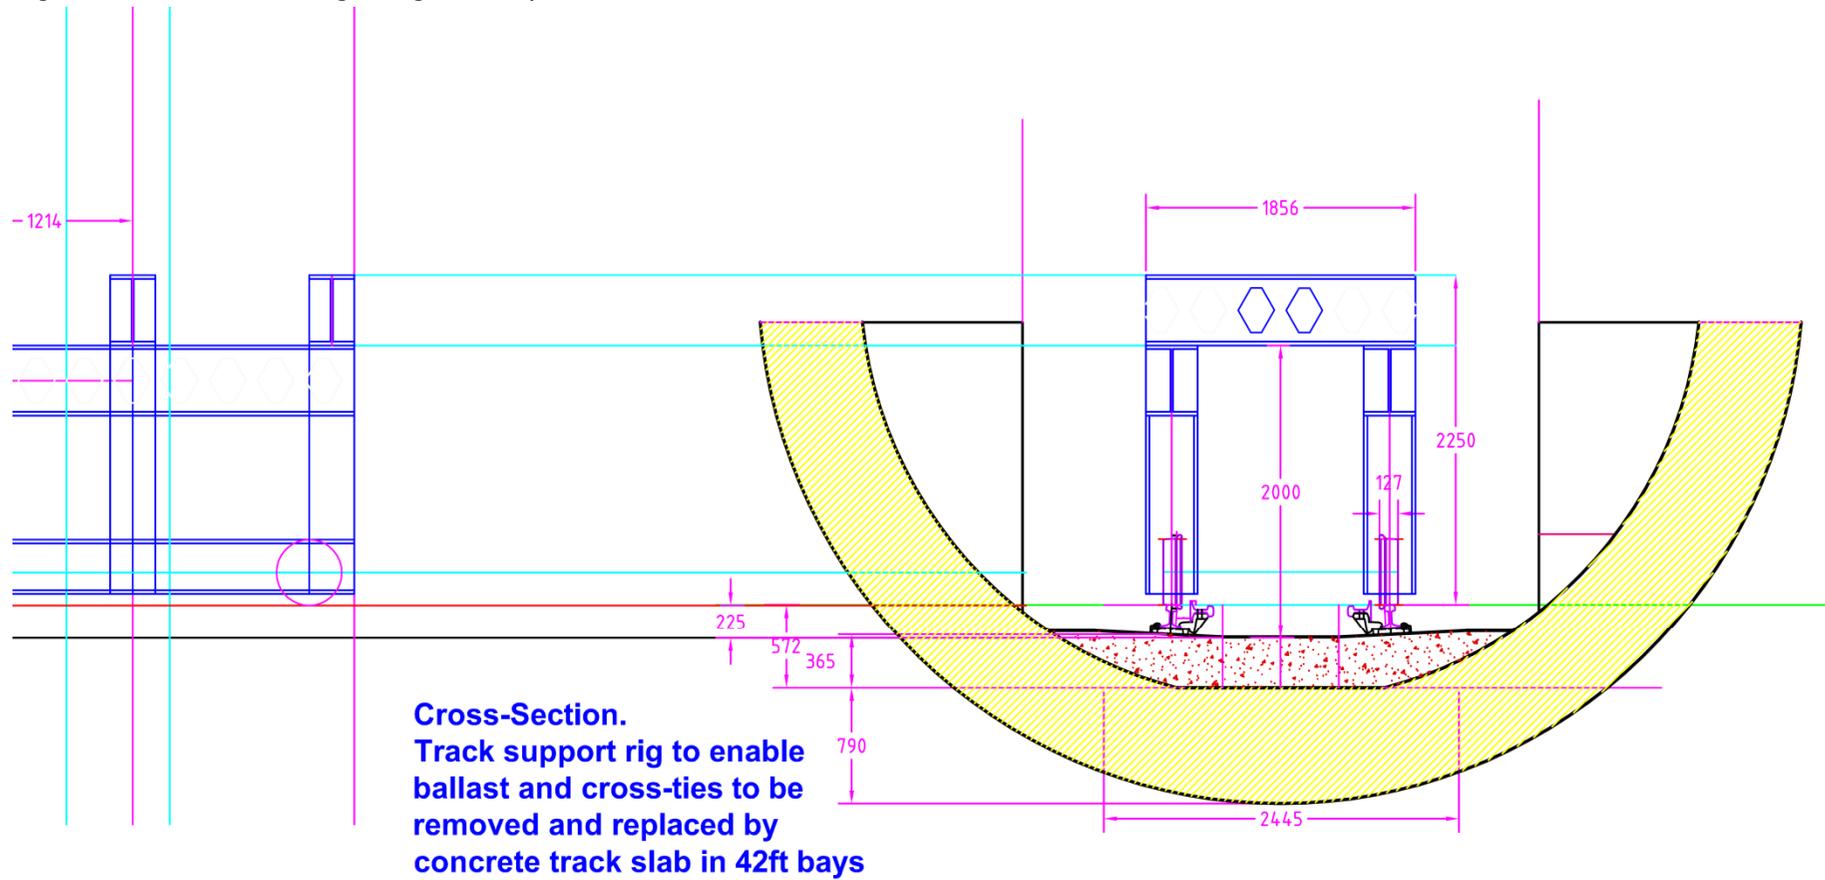
Figure A6.6 The Rolling Bridge concept – Cross-Sections

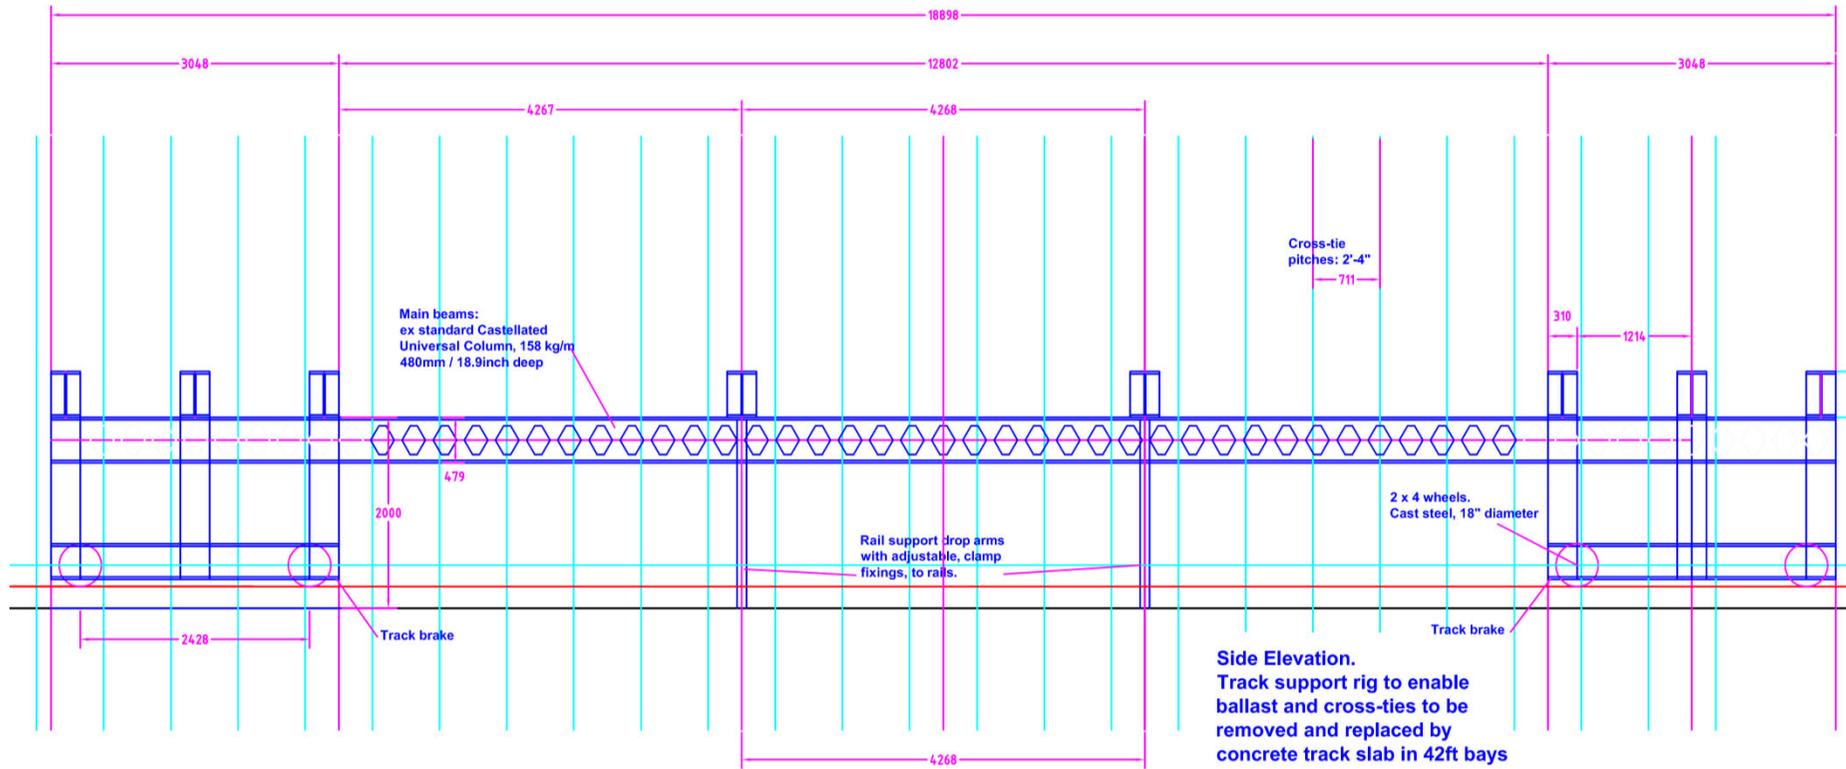
Figure A6.7 The Rolling Bridge concept – Elevation

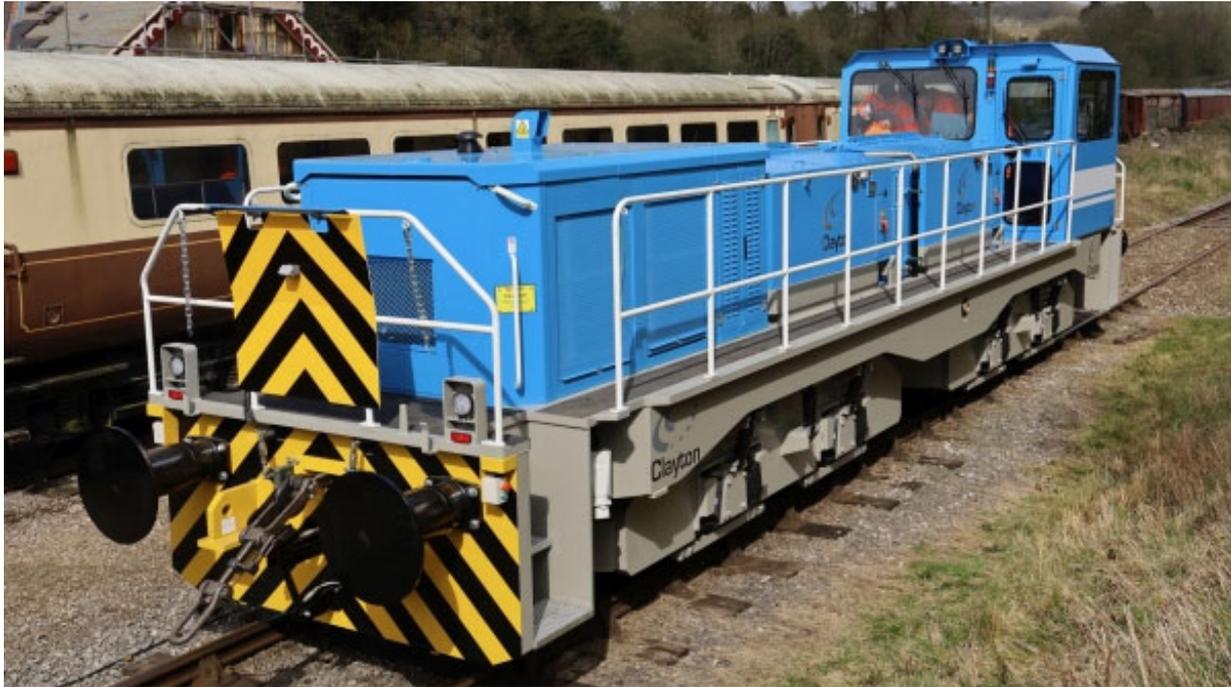
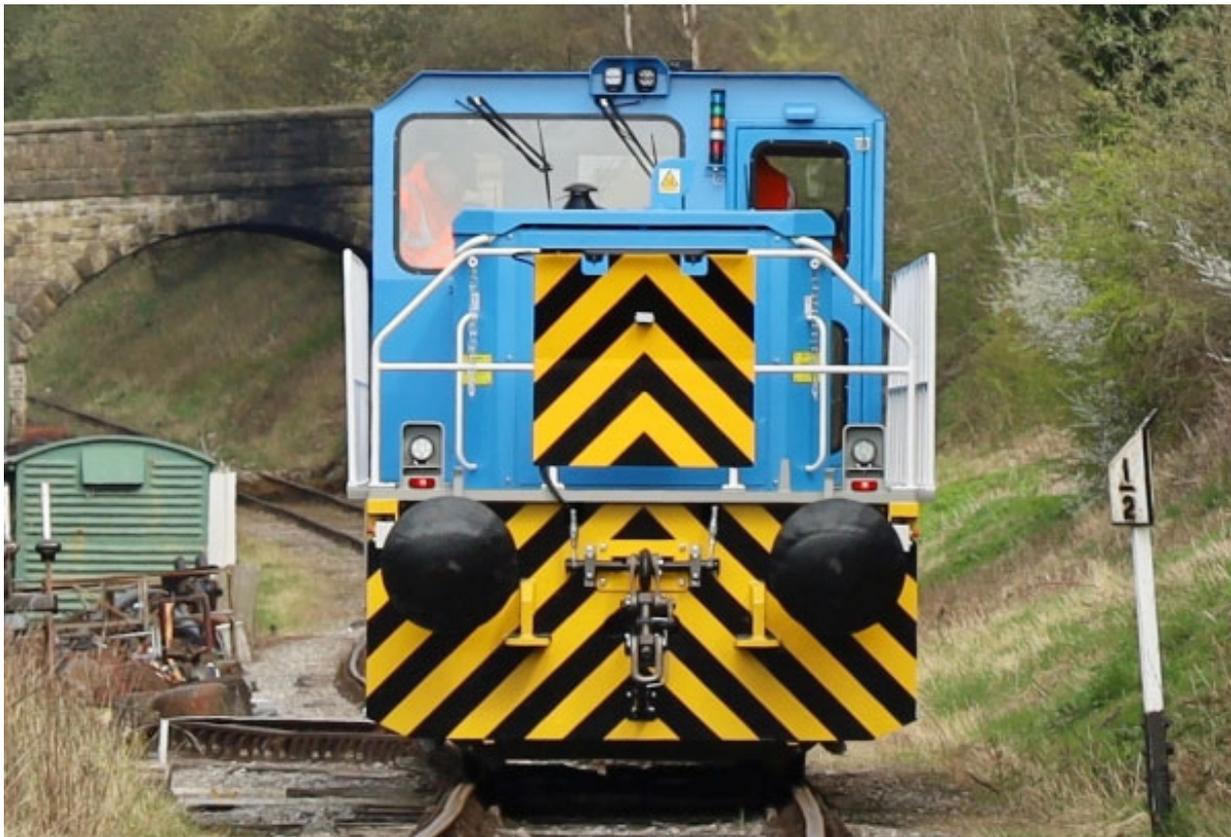
Clayton Equipment says the setup yields several advantages, including around-the-clock availability. Fuel costs and emissions are significantly reduced by the hybrid technology, and the diesel engine can operate at the optimum speed for recharging the battery on-board. Regenerative braking from both gradients and flat tracks also boosts battery charging.

Maintenance costs, time and fuel use are reduced due to the hybrid design which eliminates the need to idle, as the engine can be switched off while waiting.

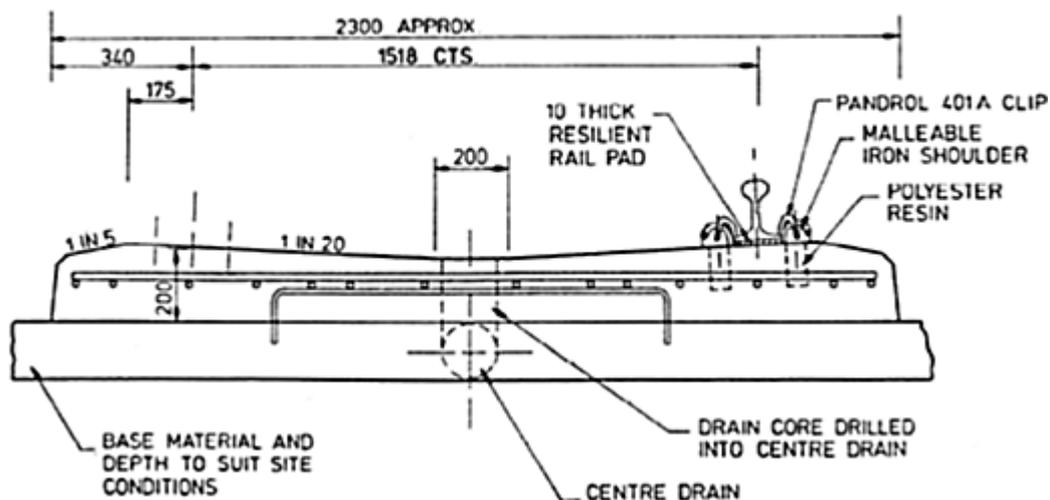
In the UK where maximum axle load is 25.5 metric tonnes / 28.1 US tons, the PACT slab is usually 200mm (8") thick under rail seats at 1500mm (59") centres and 2300mm (90.5") overall width. The 1:20 cant under the rail seats is continued towards the centre line to form a defined drainage channel. Pandrol shoulders are epoxy resin glued to holes drilled at positions to suit 113lb/yard rail, the former UK standard rail section, fixed using the standard Pandrol E-clip.

Standard cross-section drawing for a UK PACT-TRACK installation.

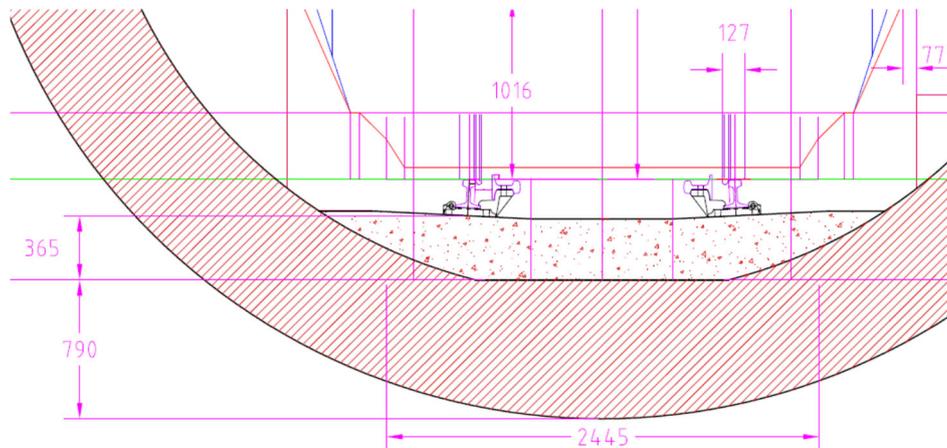
Extract from LBA Gateway Report, Figure 9.3, Slab-track in the NRT tunnel invert.

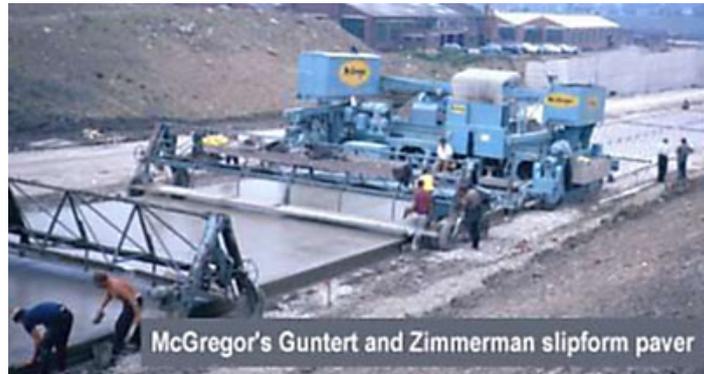
In 1972, the LBA writer was involved with construction of an early slip-paved concrete highway pavement in Somerset, England, the M5 Taunton Bypass. This new motorway was constructed on a new alignment with extensive cut and fill to produce a good vertical profile for this three-lane, dual carriageway, 70 mph highway. The slip-paved pavement was designed and laid by McGregor Paving in two passes, one three lane carriageway (11m wide) each pass, and 10.2 inches thick, with unreinforced concrete, but including dowel bars at contraction joints and tie bars across the

two longitudinal joints, (as used on the McGregor Paving railway applications). This was many years before the availability of any form of fibre-reinforced concrete.

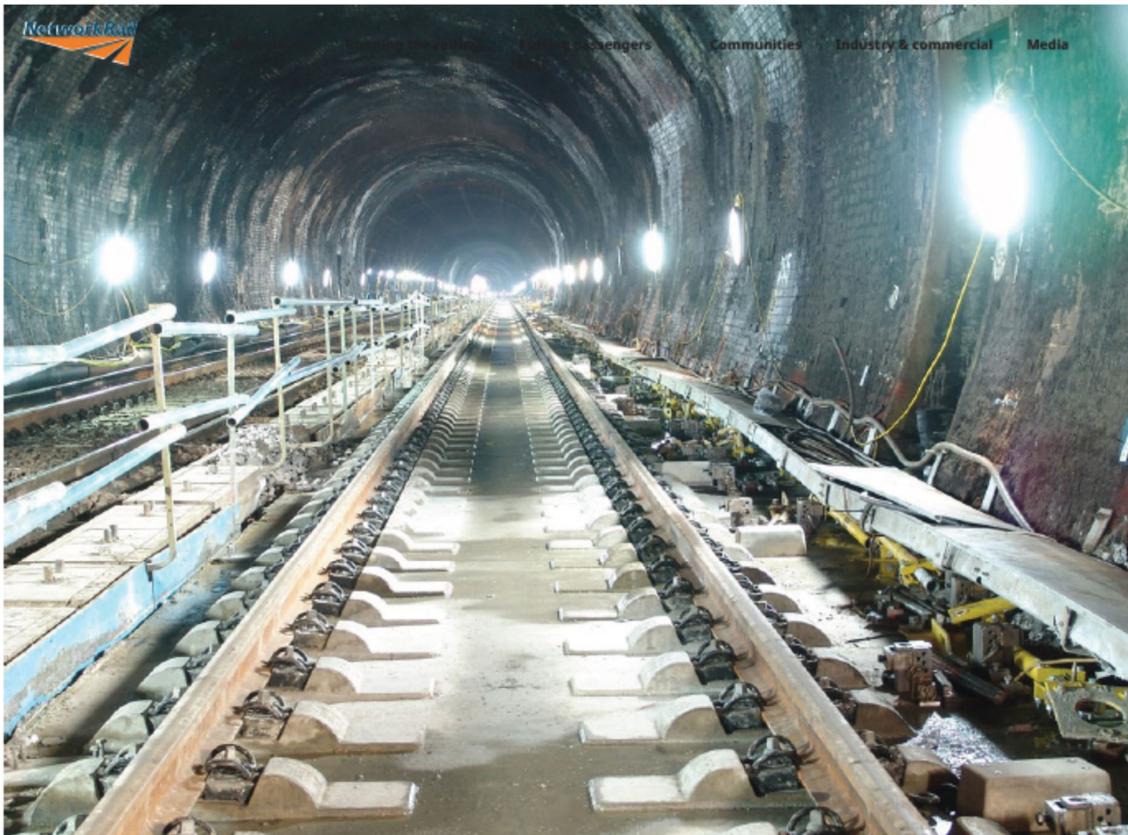
Southampton Tunnel, UK, during 12-day outage to install 1600 ft long slab-track.

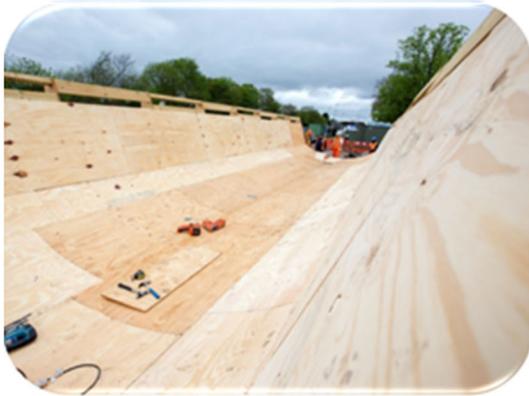
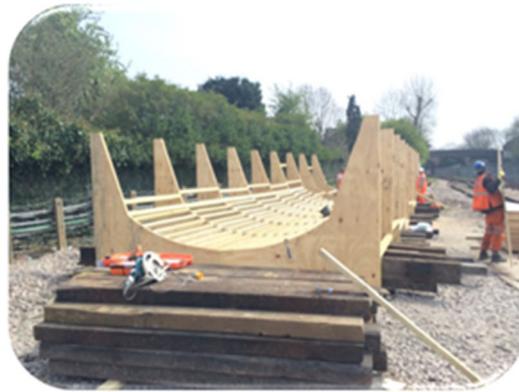
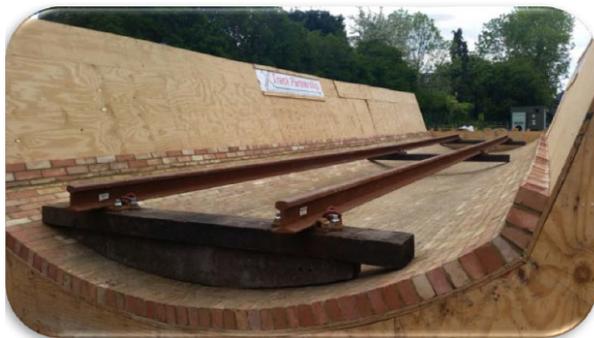
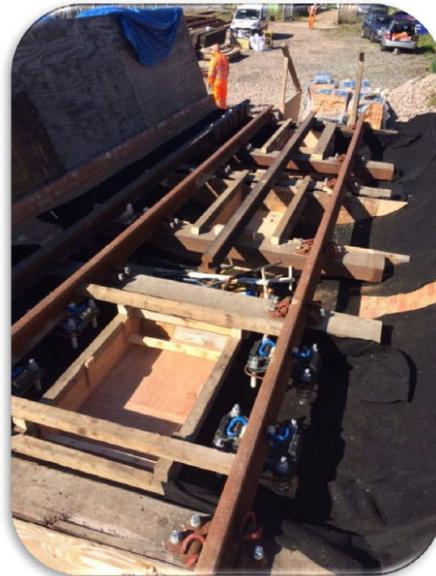
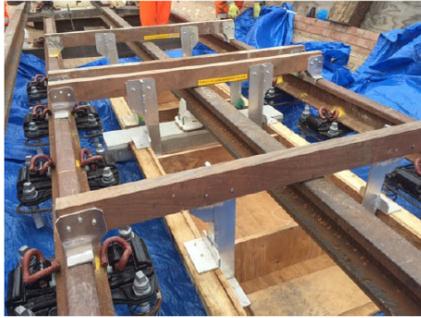
Track replacement on the Metropolitan Line (the world's first underground railway dating back to 1863) between Baker Street and Finchley Road; where 3.2 km of life expired Bullhead rail on timber sleepers in 7 single bore tunnels was replaced with concrete slab track at the rate of 10.5 m per night outage. Detailed mock-ups were prepared to develop the method and prove the concrete mix.

Figure A10.1 –Surface mock-up of the planned rail replacement for Baker Street to Finchley Road underground stations.

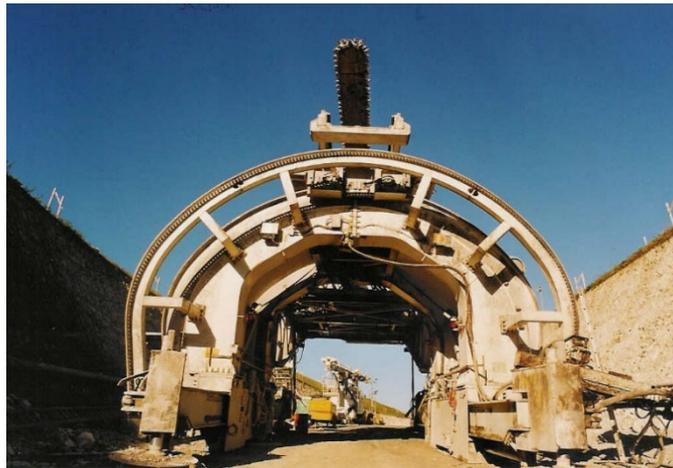
Figure A10.4: Pre vaulting tunnelling machine Ramsgate Port Access tunnel

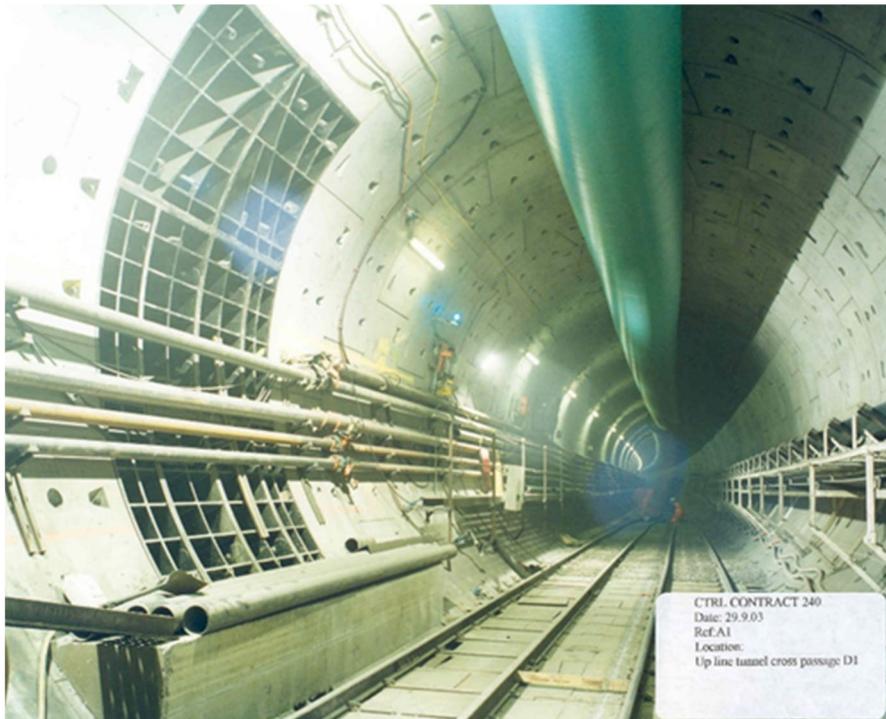
Figure A10.6: CTRL (HS1) running tunnel showing cross passage provision

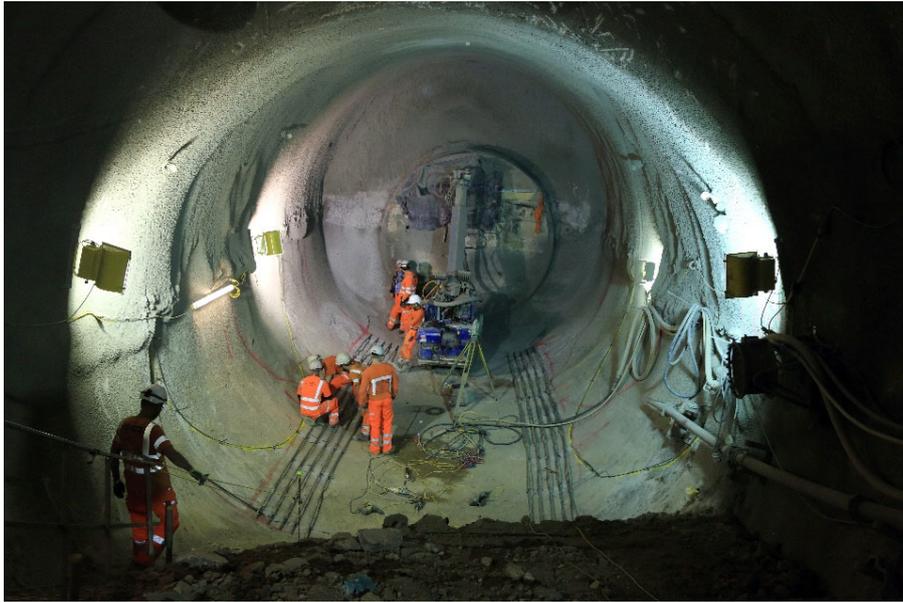
Figure A10.7: Bond Street Station Upgrade below ground works

Bond Street Station upgrade is another large and complex project on one of the busiest streets in London. The LUL station required an upgrade to improve the passenger flow and provisions had to be made to connect existing underground to the new Crossrail station nearby. The usual and also some of the unusual construction problems started to appear, so the Client brought the team together as one team with an “independent” leader under one contract. This was a very successful move which managed to get the project back on track and achieved its Sectional Completion/Handover dates.

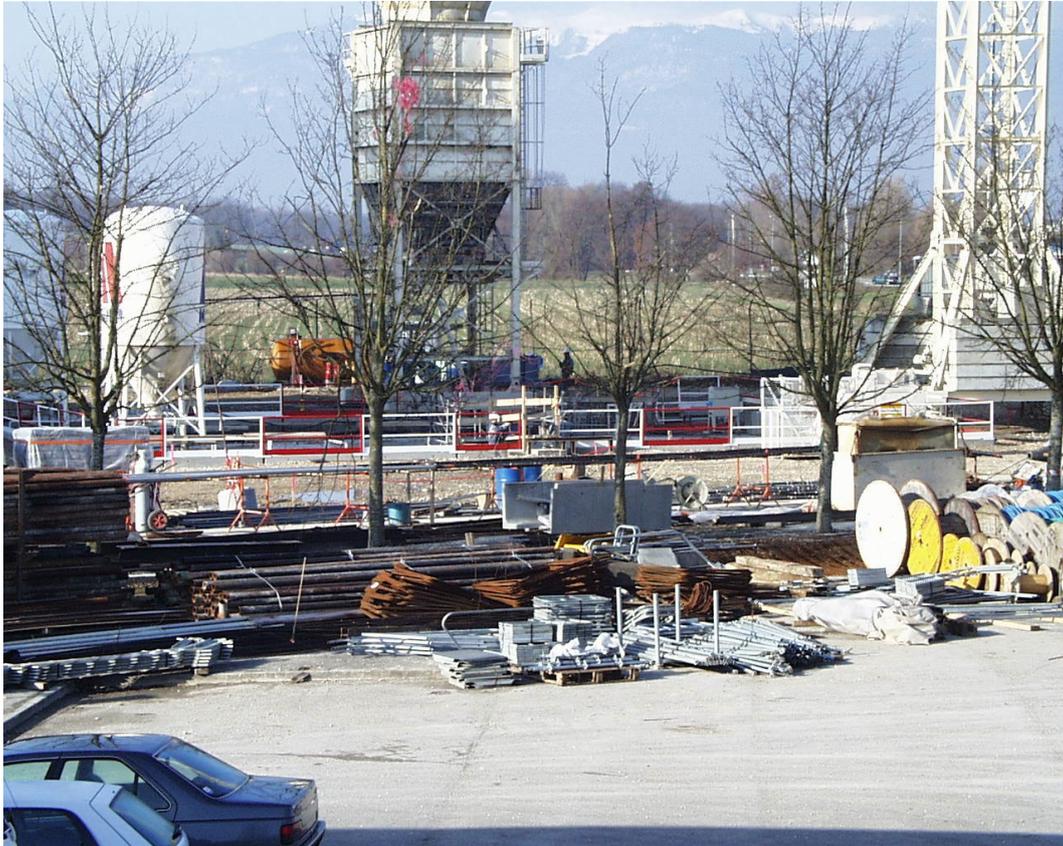
This was a project in connection with the underground particle accelerator ring. It comprised a mixture of tunnelling, earthworks, buildings and facilities. The contractor was a Joint venture between, Taylor Woodrow, AMEC and Spie Batignolles. Clients Engineer was Kellogg Brown & Root (KBR), and the Client had their own engineering and supervisory staff.

Figure A10.10: CERN Main Street Shaft

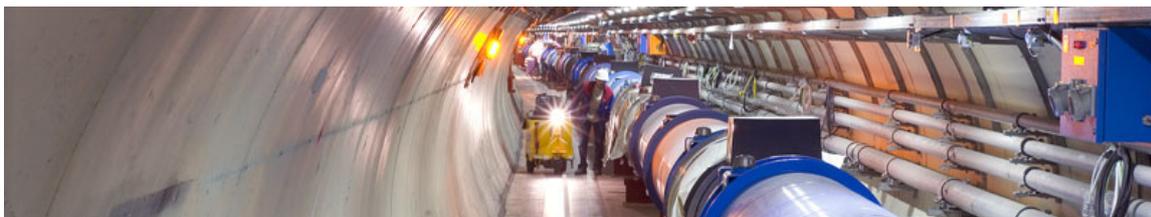
Figure A10.11: CERN Collider Tunnel

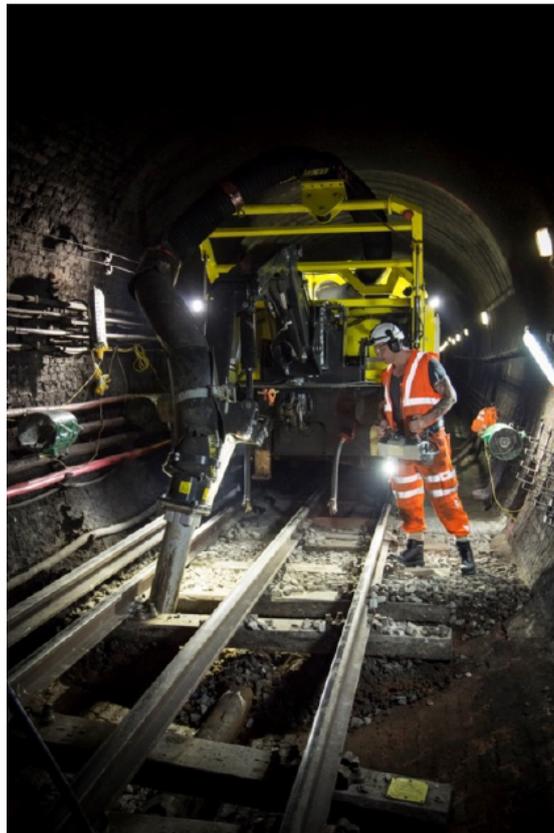
Figure A10.12: Baker Street to Finchley Road ballast removal
